2009 Cadillac XLR: Service Bulletin: #PIC4930: Audible Click Noise When turning The Steering Wheel Left Or Right

Subject: Audible Click Noise When
Turning the Steering Wheel
Left or Right

Models: 2009 Cadillac XLR
2009 Chevrolet Corvette

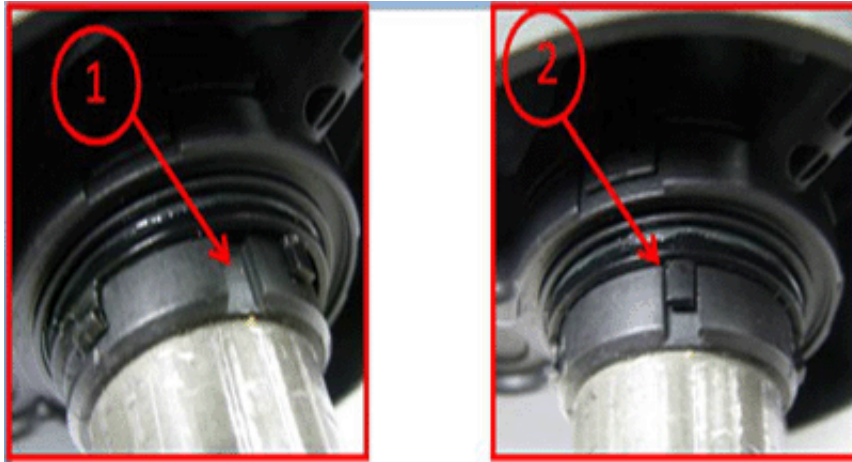
Some customers may comment of a click noise from the steering column when turning the steering wheel left or right. This will typically occur when the vehicle is not moving and the steering wheel is turned either left or right. This may be caused by the Steering Wheel Position Sensor (SWPS) not being installed correctly on the steering column.

2. Refer to the image above. Inspect the vehicle to be sure the Steering Wheel Position Sensor (SWPS) is installed correctly. In call out number 1 above, the SWPS is not installed correctly. Note: the SWPS has a tab that should rest in the opening as called out in number 2 above. In call out number 2 above, the SWPS is installed correctly. Note: The tab of the SWPS is secured in the opening. If the sensor is found to be installed incorrectly, remove or rotate the sensor so that it is installed correctly as shown in call out number 2 above.

1. Remove the close out panel just below the steering column.
