2004 - 2009 Cadillac XLR: Service Bulletin: #05-08-57-005B: General Waterleak Guide - (Oct 2, 2008)

Subject: General Waterleak Guide

Models: 2004 - 2009 Cadillac XLR

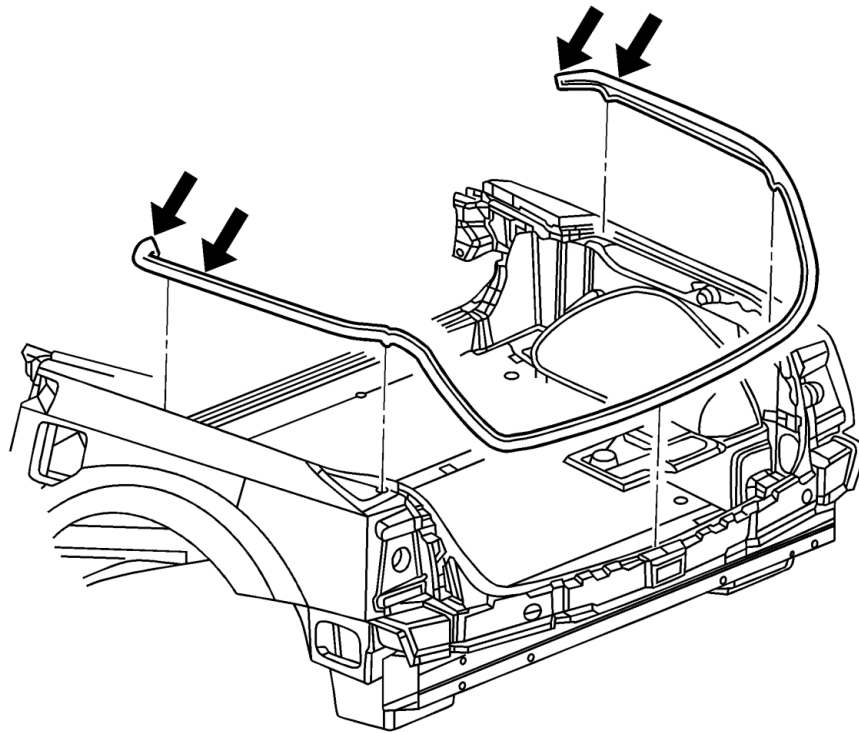
Water entry over the wheelhouse traced back to the joint between the rear compartment weatherstrip and quarter belt weatherstrip.

Separate the joints and lift each end 50-76 mm (2-3 in) enough to apply 3M™ Bedding and Glazing Compound, P/N 08509, inside the U-Channel of the weatherstrip. Refer to the illustration above. Apply enough compound so that it extends to both ends of the weatherstrip and will cause slight squeeze out when reinstalled. As you reinstall the weatherstrips, be sure the smaller weatherstrip is fully inserted into the opposite weatherstrip. Work the weatherstrips onto the flange and towards each other to ensure a tight joint when finished.

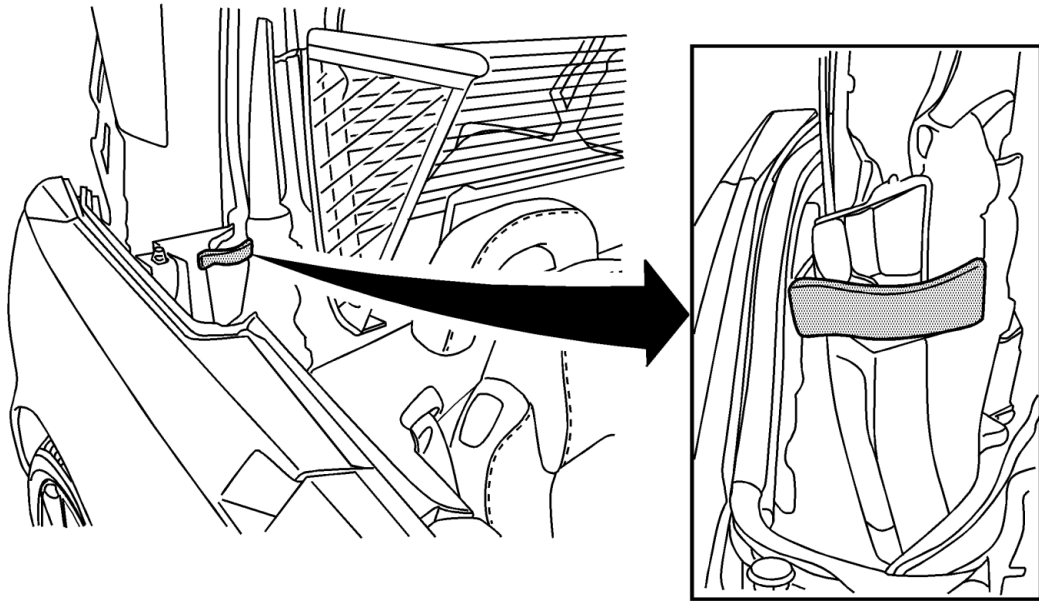
Water entry over wheel house and traced back to quarter belt cup. The cup drain is not large enough to allow water to drain adequately and floods over the dry side of the sealing system, which allows water to enter the trunk.

The cup joint is located at the rear of the quarter belt seal and it looks like a trough. This area is where the rear roof panel lower weatherstrip contacts when the roof is closed. The area just forward (toward front of car) of this cup is a “wet area” and to better manage the water into this wet area, a strip of foam must be added into the rear roof panel lower weatherstrip where it contacts the cup. Cut a strip of adhesive backed foam Kent Adhesive – Back Shim Stock, P/N P46475, 60 mm X 15 mm (2 1/4 in X 5/8 in). Clean the area of the rear roof panel lower weatherstrip where the foam will be added using de-natured alcohol before installing the foam strip to ensure adhesion. Refer to the illustration above.

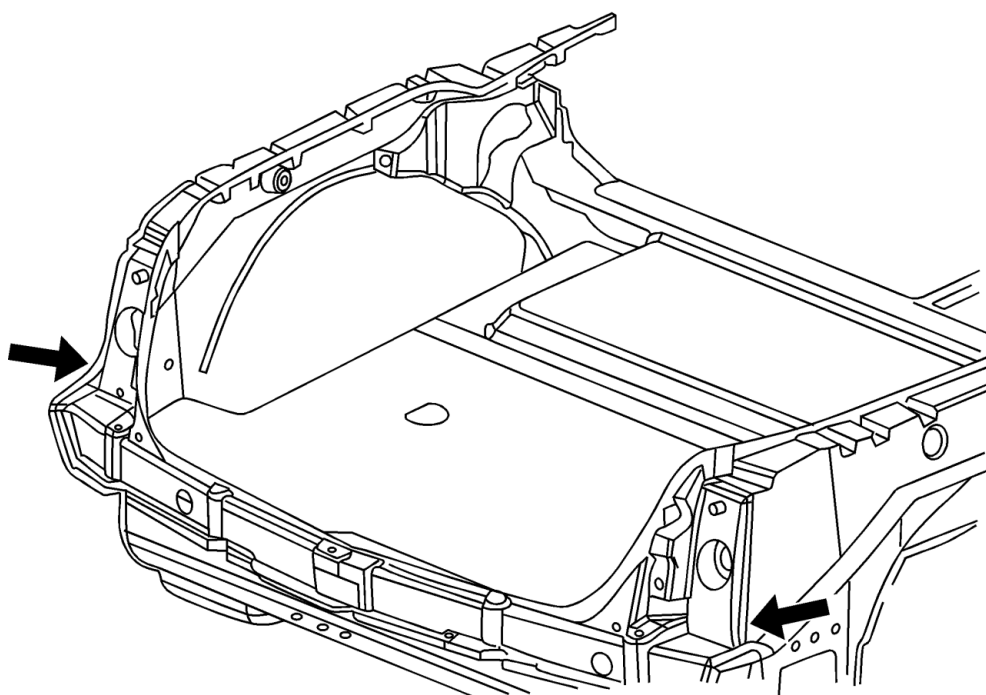
Water entry into rear tubs located behind the rear wheelhouses traced to the area behind the rear tail lamps.

There are a number of panels that are bonded together in this area. If water entry is traced to this area, remove the rear tail lamp on the affected side to help gain access. Use Kent Seam Sealer, P/N P10200, to seal the affected joint. Refer to the illustration above.

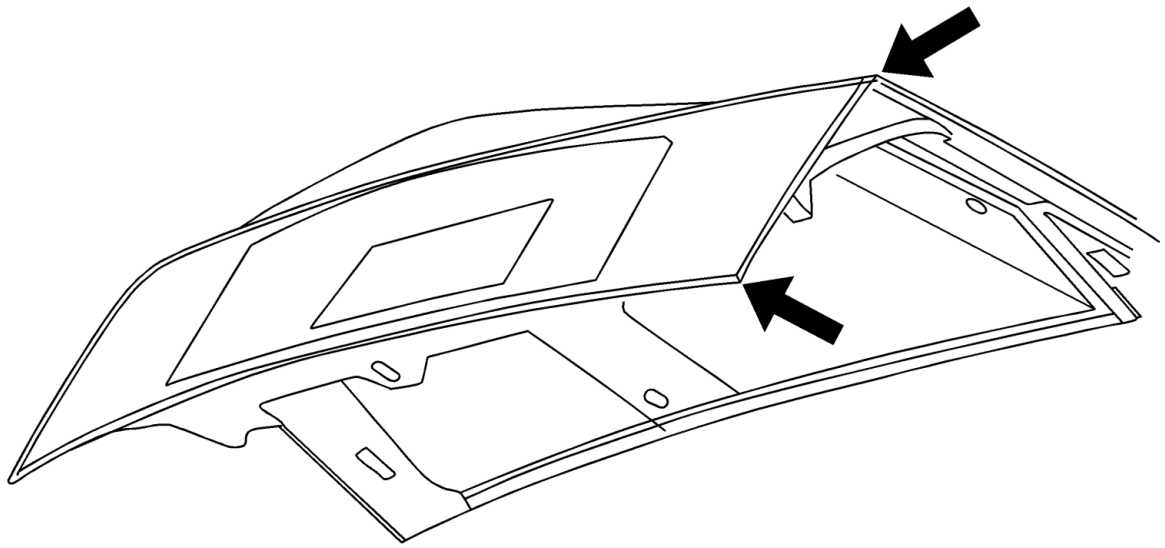
Water entry into the rear compartment. Water may be present on the sill of the lower rear compartment opening (near the latch). Water may be seen dripping from the rear compartment lid inner trim at the lower corners.

Seal the area of the rear compartment lid inner and outer panels at the outer most vertical seam (between arrows – either side). The seam is on the inside of the rear compartment lid. Refer to the illustration above. Use Kent Seam Sealer, P/N P10200, to seal the seam for best appearance.
