# 2006 - 2009 Cadillac XLR: Service Bulletin: #PI0299: Harsh Shifts After Replacement of 1-2-3-4 / 3-5-R Clutch Housing

## #PI0299: Harsh Shifts After Replacement of 1-2-3-4 / 3-5-R Clutch Housing - (Nov 16, 2010)

**Models:** 2006 - 2009 Cadillac XLR  
2006-2011 Cadillac STS  
2007-2011 Cadillac Escalade Models  
2008-2011 Cadillac CTS  
2006-2011 Chevrolet Corvette  
2007-2011 Chevrolet Silverado  
2008-2011 Chevrolet Suburban  
2009-2011 Chevrolet Avalanche, Tahoe  
2010-2011 Chevrolet Camaro, Express  
2007-2011 GMC Sierra, Yukon Denali, Yukon Denali XL  
2008-2011 GMC Yukon XL  
2009-2011 GMC Yukon  
2010-2011 GMC Savana  
2008-2009 HUMMER H2  
2008-2009 Pontiac G8  
Equipped with 6L45, 6L50, 6L80 or 6L90 Automatic Transmission (RPOs MYA, MYB, MYC, MYD)

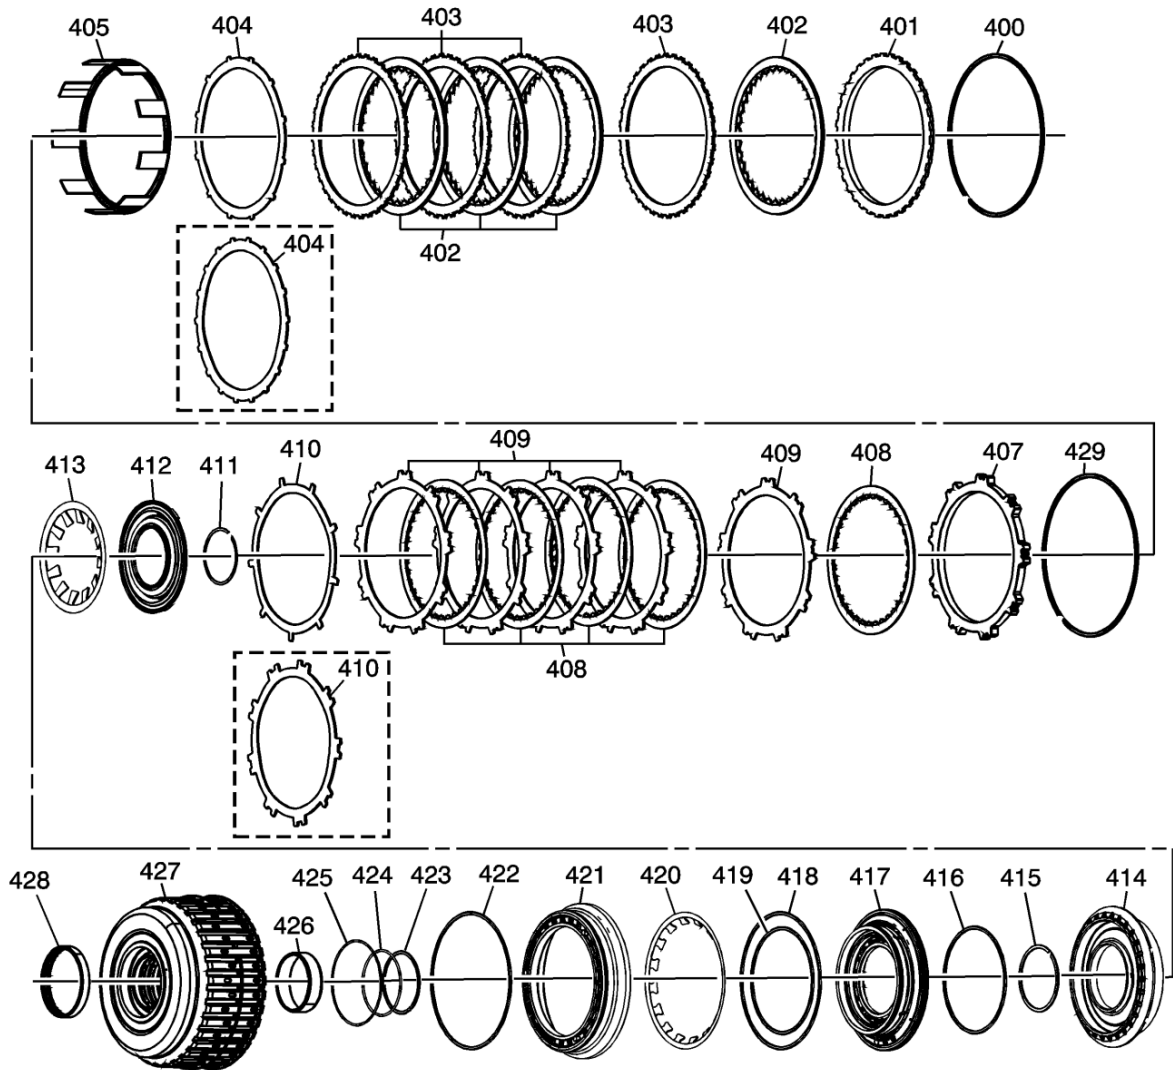
Some customers may comment on harsh shifts after replacement of the 1-2-3-4 / 3-5-R clutch housing (427).

This condition may be caused if the 1-2-3-4 / 3-5-R bearing (428) is not installed into the housing (427). The 1-2-3-4 / 3-5-R clutch housing is currently serviced through parts without this bearing installed and failure to order and install this bearing may result in harsh shifts. Plans are being implemented to service this housing as a kit that will include

**Note:** The parts catalog calls out to order the bearing when the housing is also replaced.
