# **2006 - 2009 Cadillac XLR-V: Service Bulletin: #PIP4493: SES Light due to DTCs P0171 and/or P0174 - Inspect Air Cleaner Outlet Duct and Supercharger Inlet Duct Clamps**

## **#PIP4493: SES Light due to DTCs P0171 and/or P0174 - Inspect Air Cleaner Outlet Duct and Supercharger Inlet Duct Clamps - (Oct 3, 2008)**

**Models:** 2006 - 2009 Cadillac STS-V, XLR-V  
with 4.4L Supercharged V8 Engine (RPO LC3)

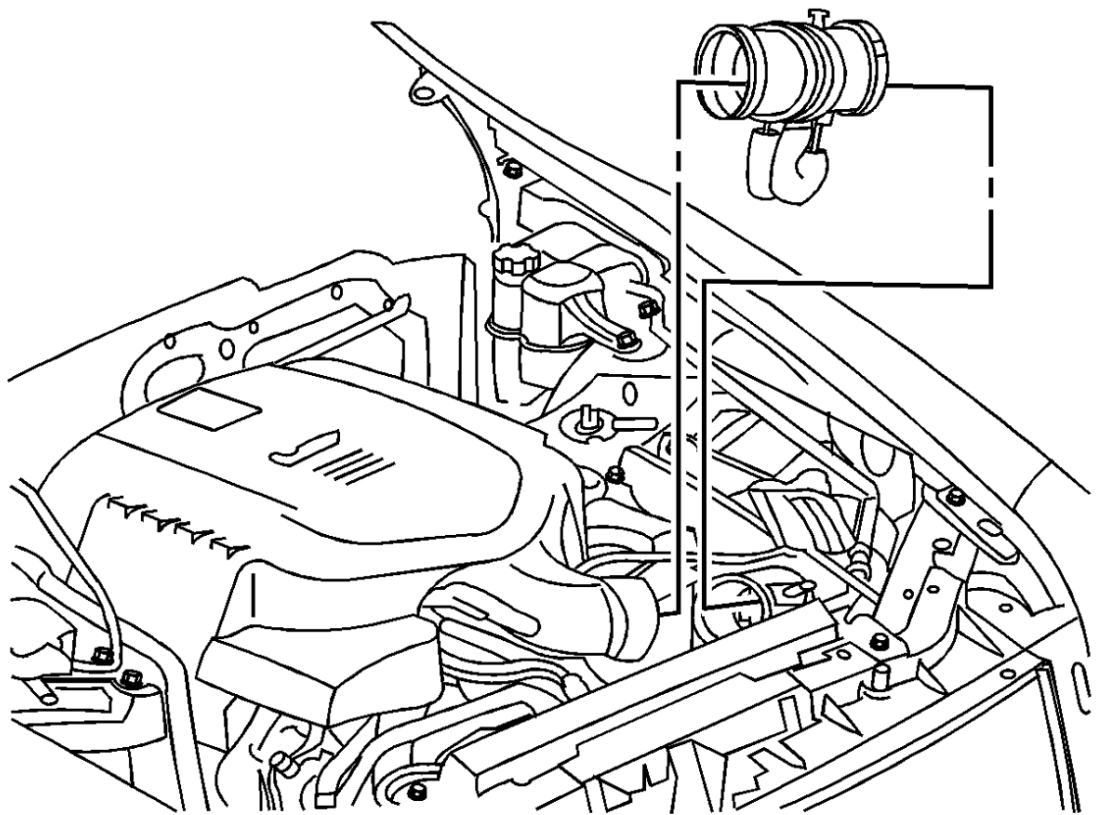
A SES light may be experienced as a result of DTCs P0171 and/or P0174 stored. This may be the result of unmetered air entering the engine through the air cleaner outlet duct or supercharger inlet duct connections due to a mis-assembled connection or loose clamps.

- 1) Tighten the air cleaner outlet duct clamps to 3 NM (27 lb-in).
