# 2006 - 2009 Cadillac XLR XLR-V: Service Bulletin: Slips in Reverse or Third, Delayed Reverse or Drive Engagement

## #09-07-30-004J: Slips in Reverse or Third, Delayed Reverse or Drive Engagement, DTC P0776, P2715, P2723, Harsh 2-3 Shifts (Inspect 1-2-3-4 / 3-5-R Housing and Pump Seal Rings) - (Feb 25, 2014)

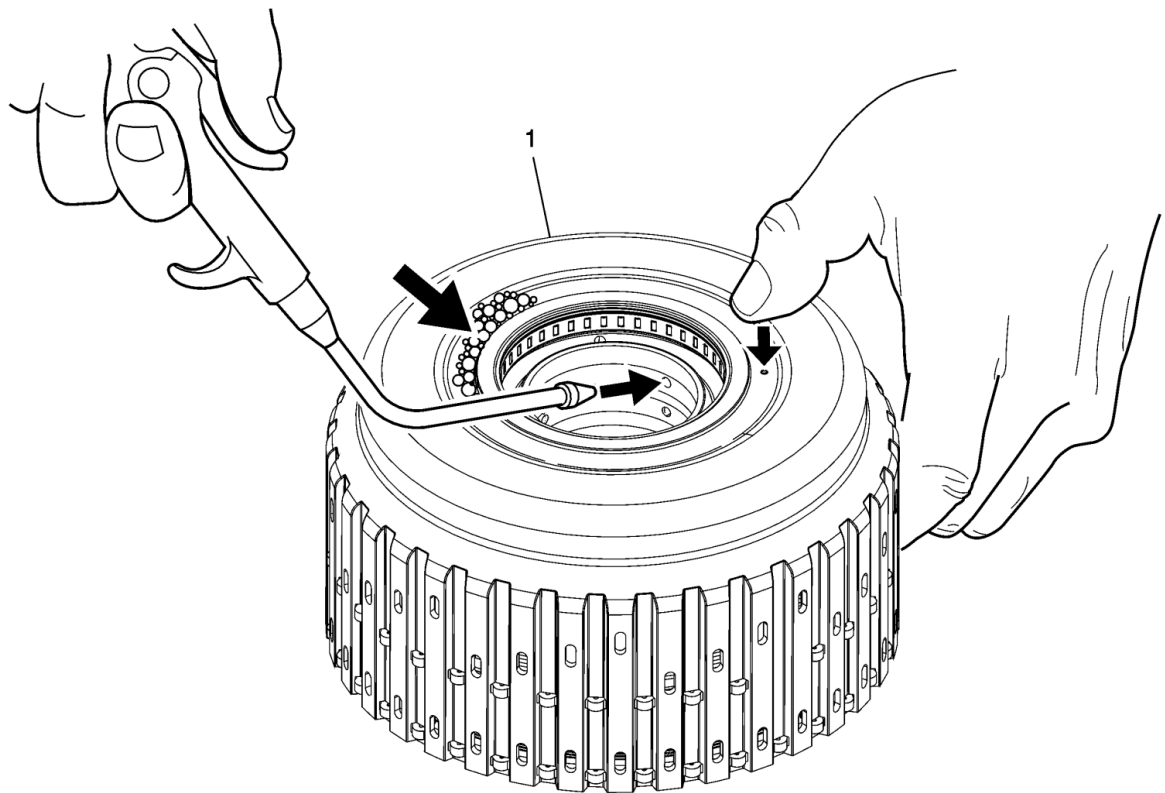
### **Housing Assembled**

This condition may be caused by a cracked 1-2-3-4 / 3-5-R clutch housing.

Inspect the 1-2-3-4 / 3-5-R clutch housing for a possible cracked weld. The housing can be inspected either assembled or disassembled.

1. Apply soap compound to the weld area of the housing.
2. Hold your thumb over the air bleed passage.
3. For a fully assembled 1-2-3-4 and 3-5 reverse clutch housing, spray compressed air into the 3-5R clutch feed hole and inspect the weld area for bubbles.
4. If bubbles are detected, a new housing is required.

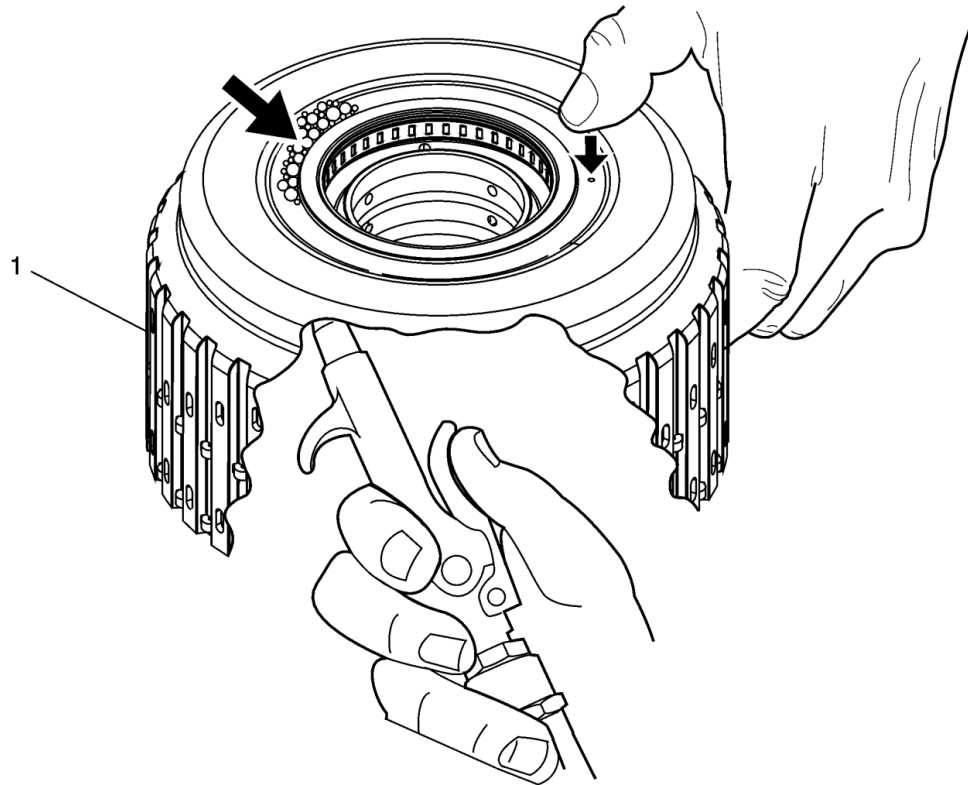
### **Housing Disassembled**

Inspect the 1-2-3-4 / 3-5-R clutch housing for a possible cracked weld.

1. Apply soap compound to weld area of the housing.
2. Hold your thumb over the air bleed passage.
3. Spray compressed air into the housing and inspect the weld area for bubbles.
4. If bubbles are detected, a new housing is required.

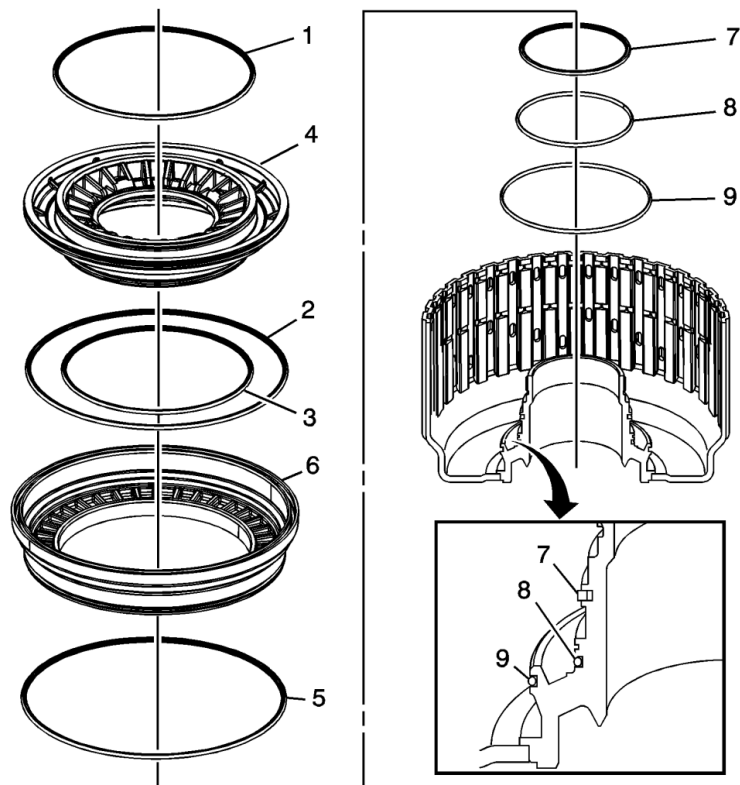
**Important:** The 6L80 transmission had a design change to the 1-2-3-4 piston, 1-2-3-4 piston housing and the 3-5-R piston for the 2008 model year. Installation of a 2008, 6L80 complete housing assembly into a 2007 or older 6L80 may result in a 2-3 shift flare or 3-5-R clutch distress.

**Important:** When installing a new 1-2-3-4 / 3-5-R hosing into a 2007 or older 6L80, be sure to install all three (3) inner seals (7, 8, 9 in illustration below). Failure to install these seals can result in no reverse, no forward or distressed clutches.

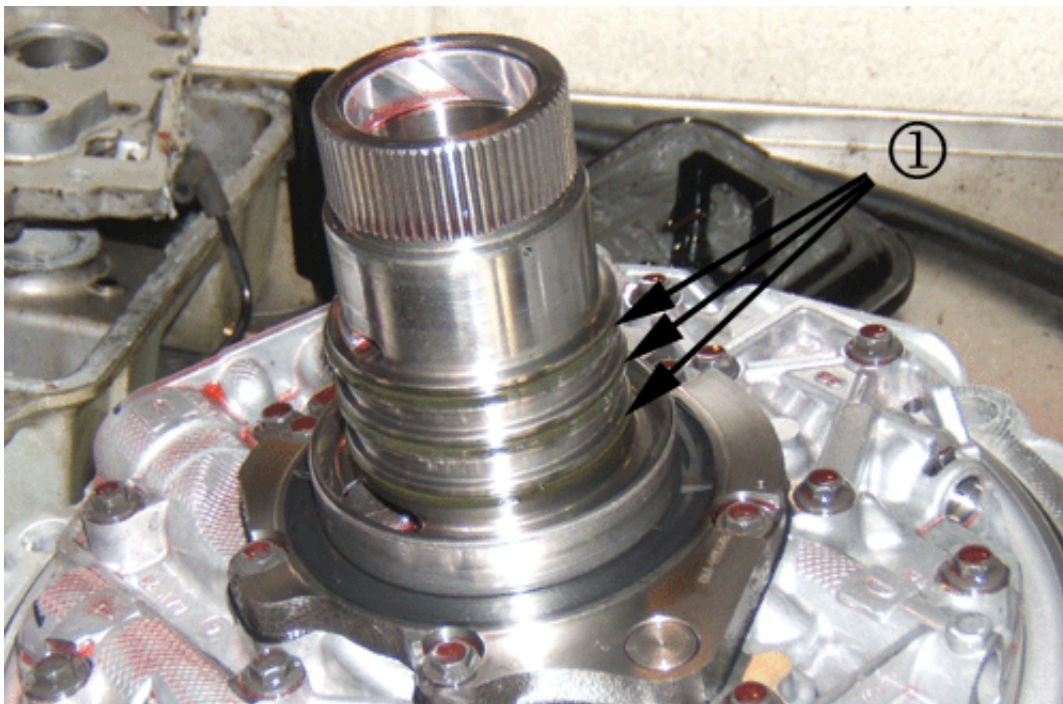
A harsh 2-3 shift condition may be caused by leaking 1-2-3-4 and 3-5-R clutch fluid seal rings (1) on the transmission fluid pump cover assembly.

Inspect the fluid seal rings. Transmissions in 2006, 2007, 2008 and early build 2009 models used a 1- piece design seal ring in production. Starting December 2008, a 2-piece seal ring design was implemented. The 1-piece seal ring design may cause a harsh 2-3 shift

due to leakage. This is typically a low mileage issue. If the seal rings are a 1-piece design they should be replaced with new 1-piece design seal rings. It is not necessary to replace the pump cover.

**Notice:** The clutch fluid seal rings must be installed in a specific way. Failure to install new clutch fluid seal rings in the proper orientation may cause a repeat harsh 2-3 shift. Refer to 1-2-3-4 and 3-5 Reverse Clutch Fluid Seal Ring Installation (6L80/90) in SI for correct installation.

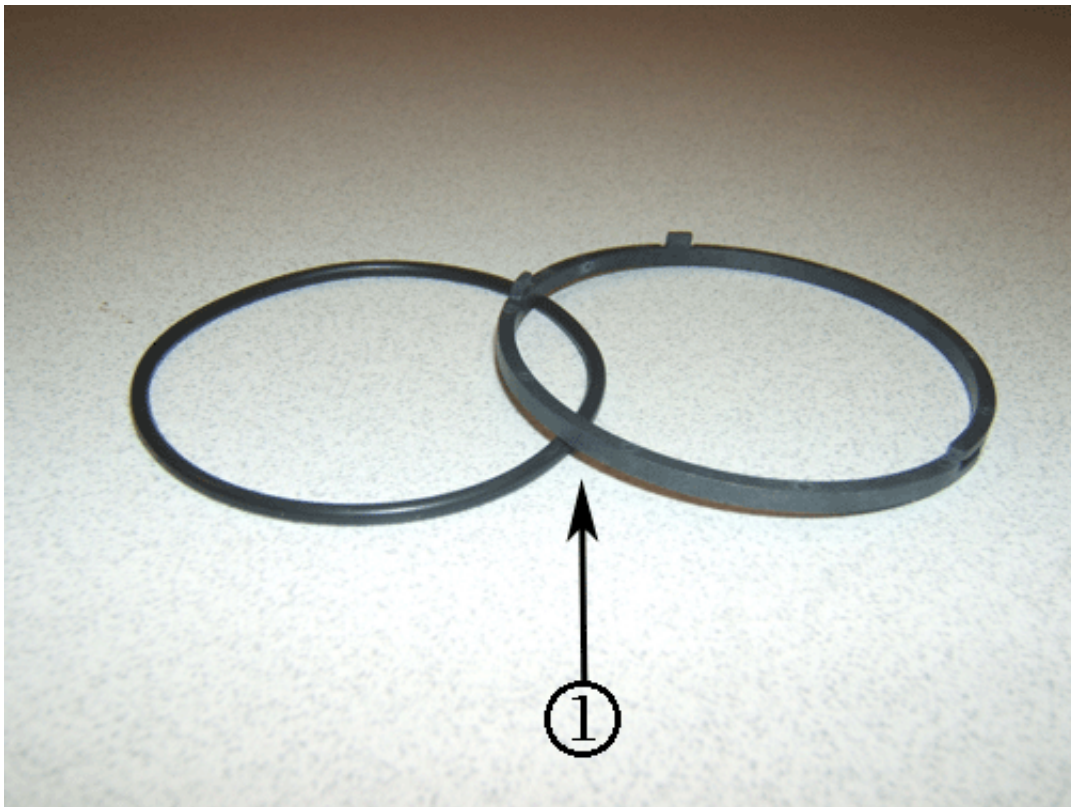
If the seals are the 2-piece design shown below, they do not need to be replaced unless they are worn or damaged.

**Important:** Do not install 1-piece design seal rings on a 2-piece seal ring design pump cover. The 2-piece seal ring design pump cover can be identified by the notch in the seal ring grooves that accepts the tab on the 2-piece design seal rings.
