2006 - 2009 Cadillac XLR XLR-V: Service Bulletin: #16-NA-130: No Reverse, No Second After Upper Valve Body Replacement

#16-NA-130: No Reverse, No Second After Upper Valve Body Replacement - (Apr 27, 2016)

Subject: No Reverse, No Second After Upper Valve Body Replacement

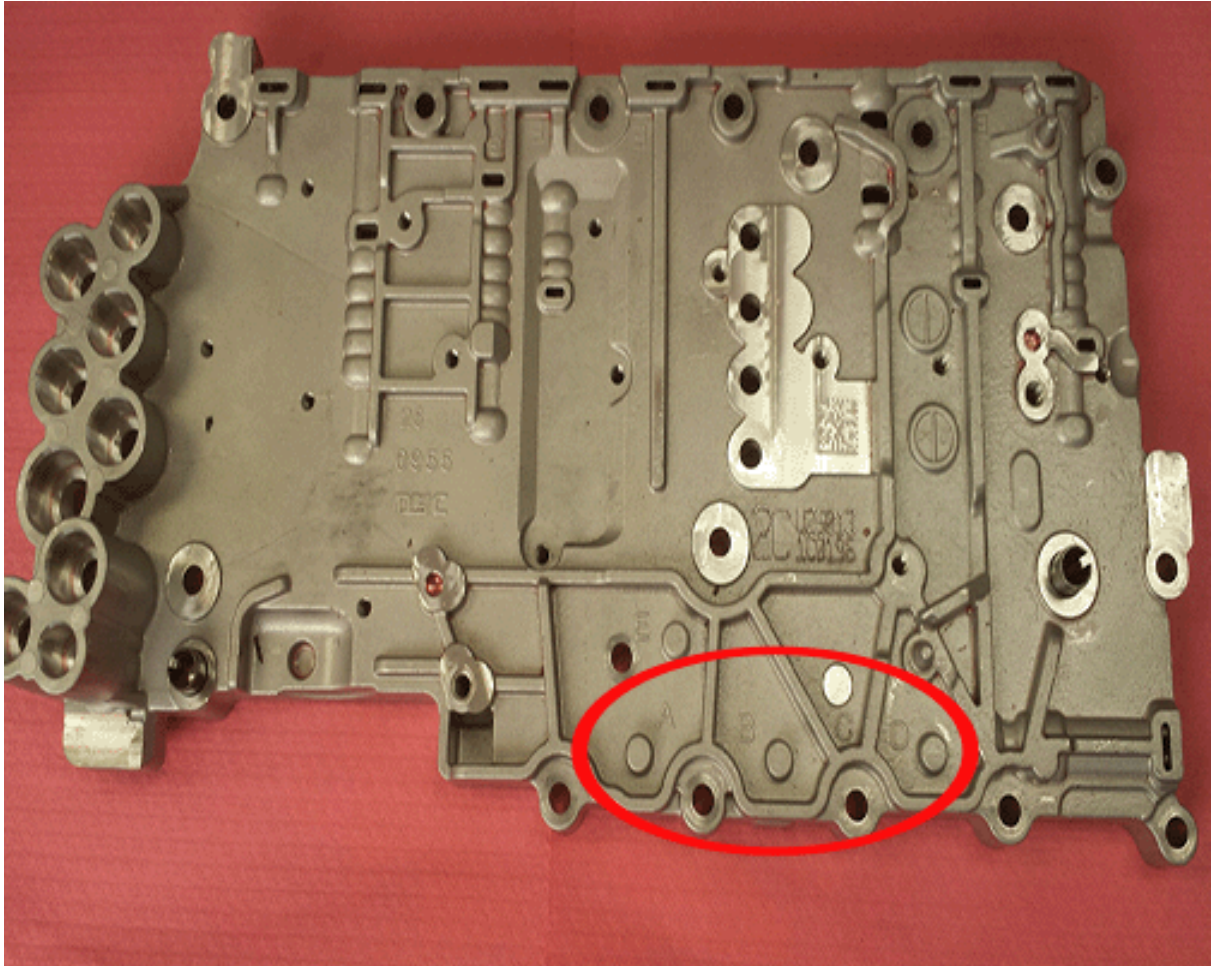
Location of the four post shown above.

Upper valve bodies are unique by transmission RPO. Each upper valve body has four posts labeled A, B, C and D on the top side of the upper valve body. Inspect the upper valve body as shown below to determine the correct RPO usage.

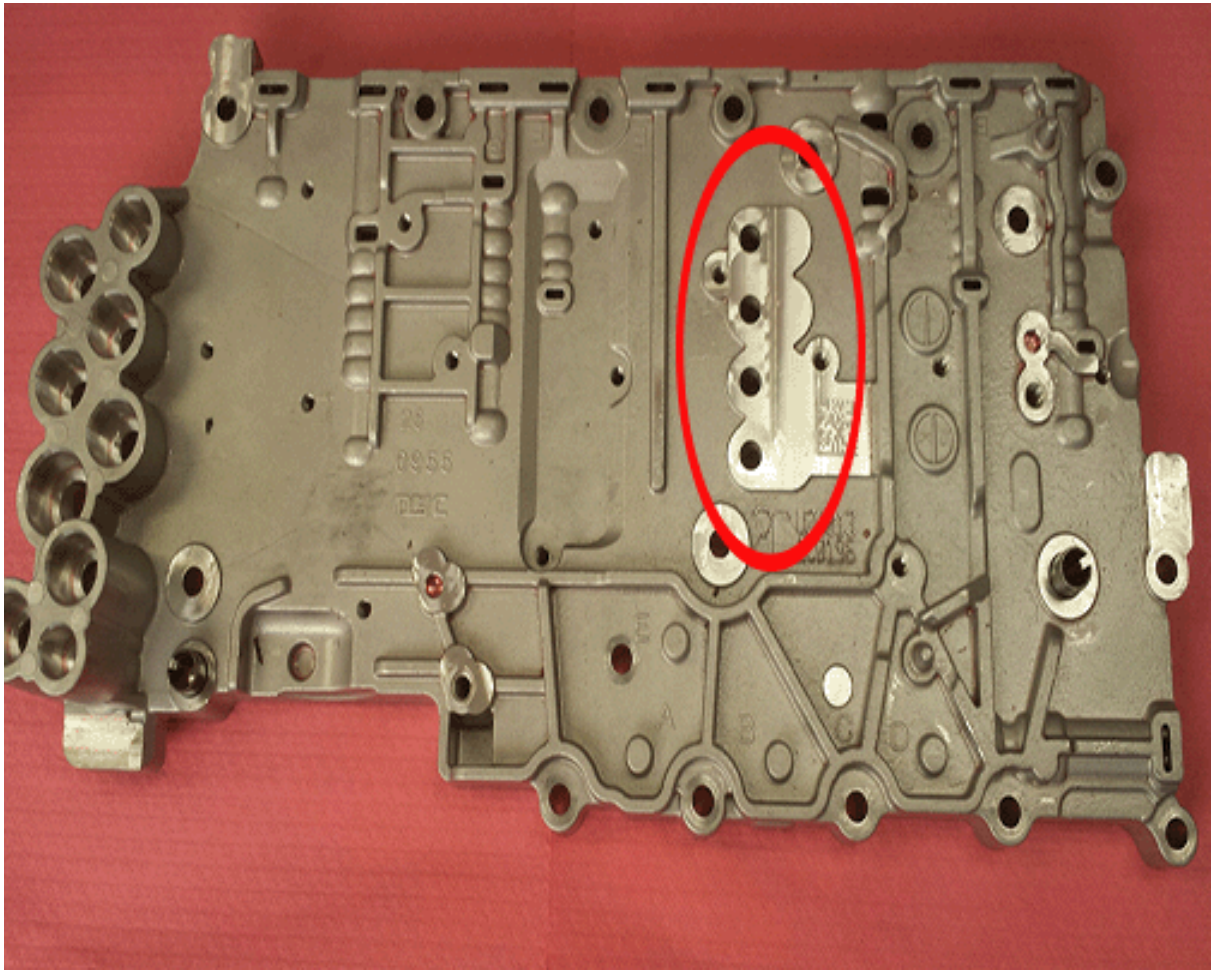
The oil passage holes that feed the center support and Low and Reverse Clutch and 2-6 Clutch contained within the center support vary location by transmission and corresponding upper valve body. The ISS and OSS mounting locations also vary by transmission. The incorrect valve body does not properly locate the oil feed holes and speed sensors.
