# 2006 - 2009 Cadillac XLR XLR-V: Service Bulletin: #16-NA-130: No Reverse, No Second After Upper Valve Body Replacement

## #16-NA-130: No Reverse, No Second After Upper Valve Body Replacement - (Apr 27, 2016)

**Subject:** No Reverse, No Second After Upper Valve Body Replacement

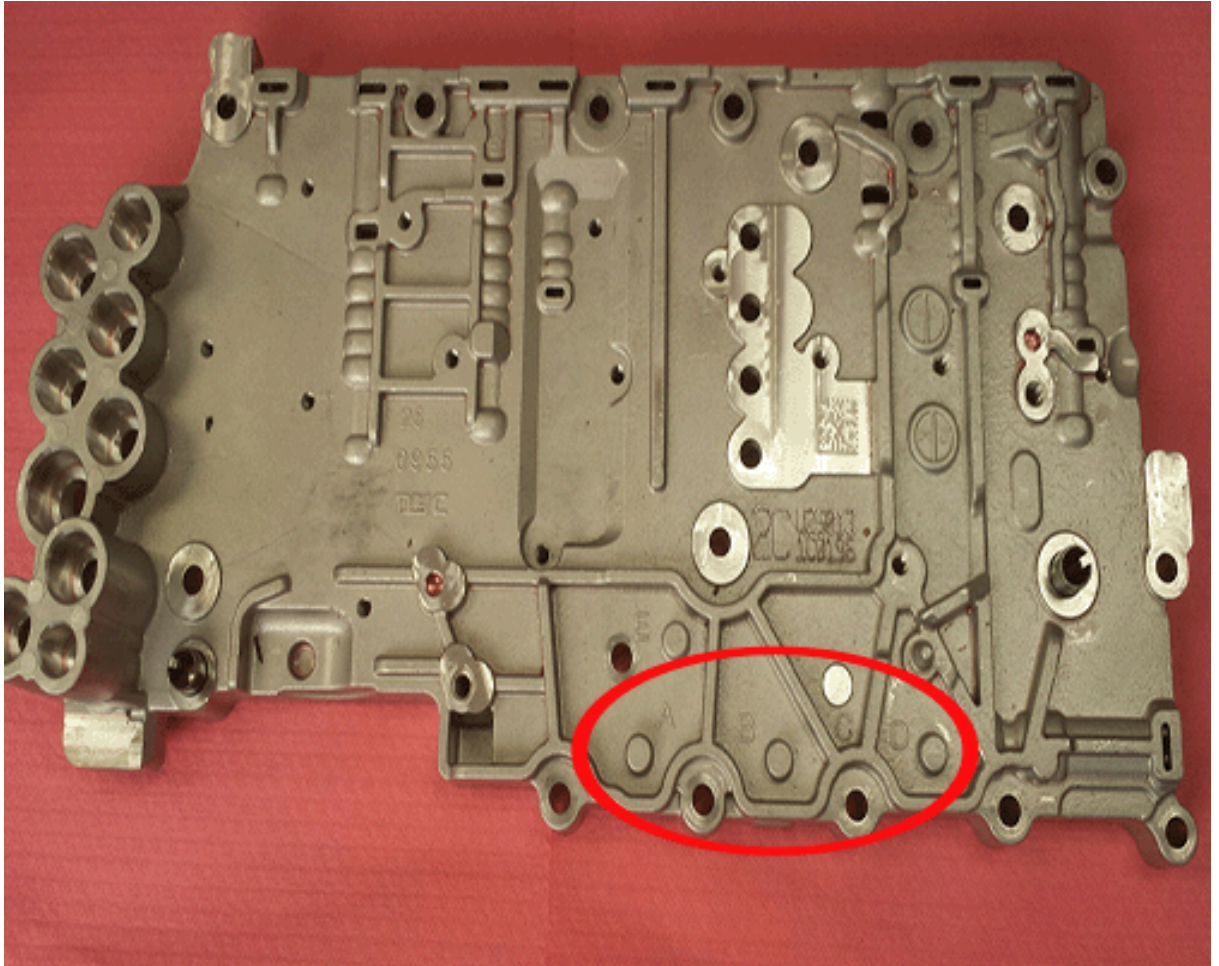
Location of the four post shown above.

Upper valve bodies are unique by transmission RPO. Each upper valve body has four posts labeled A, B, C and D on the top side of the upper valve body. Inspect the upper valve body as shown below to determine the correct RPO usage.

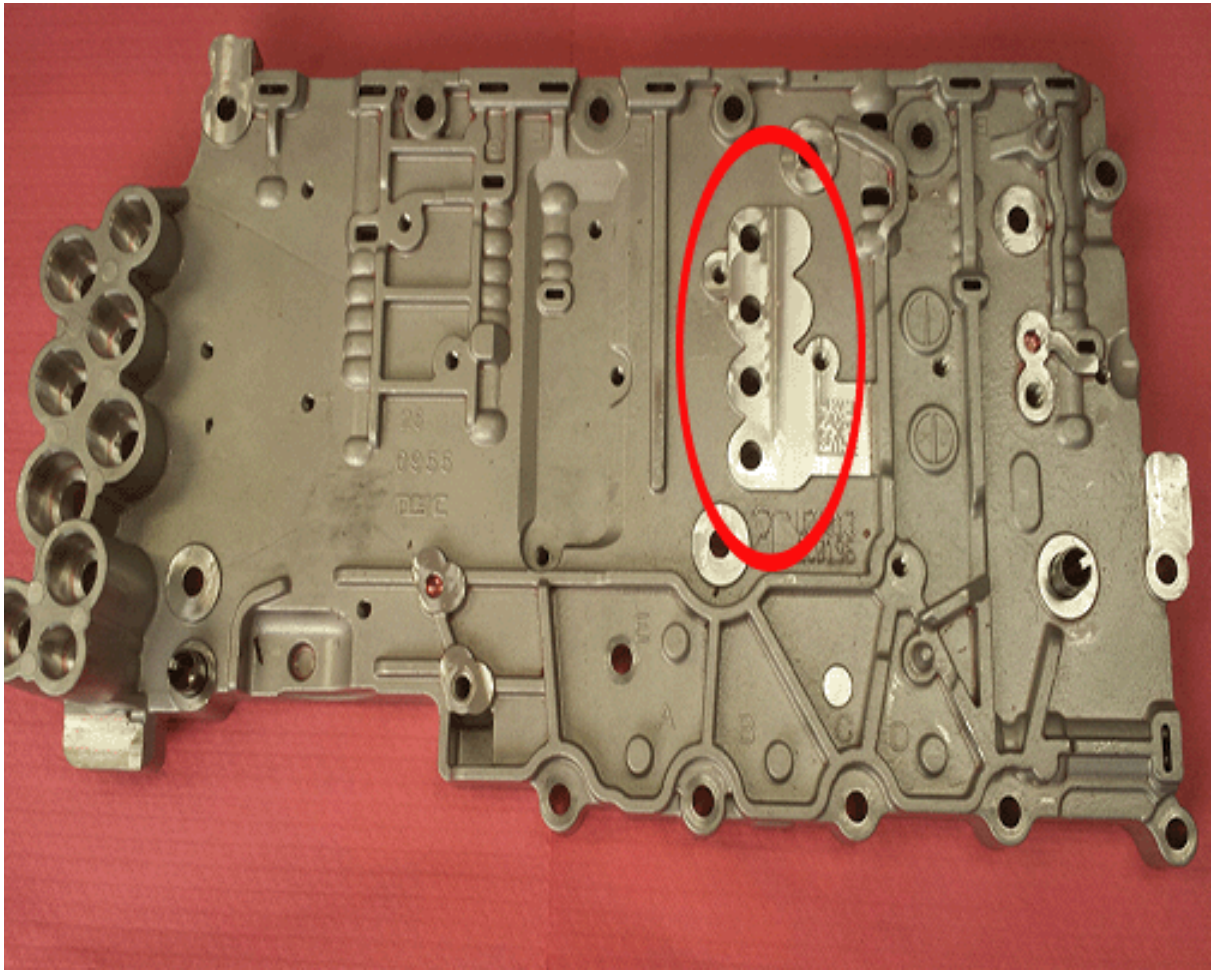
The oil passage holes that feed the center support and Low and Reverse Clutch and 2-6 Clutch contained within the center support vary location by transmission and corresponding upper valve body. The ISS and OSS mounting locations also vary by transmission. The incorrect valve body does not properly locate the oil feed holes and speed sensors.
