2004 - 2009 Cadillac XLR: Service Bulletin: #05-08-57-005B: General Waterleak Guide - (Oct 2, 2008)

Subject: General Waterleak
Guide

Models: 2004 - 2009 Cadillac
XLR

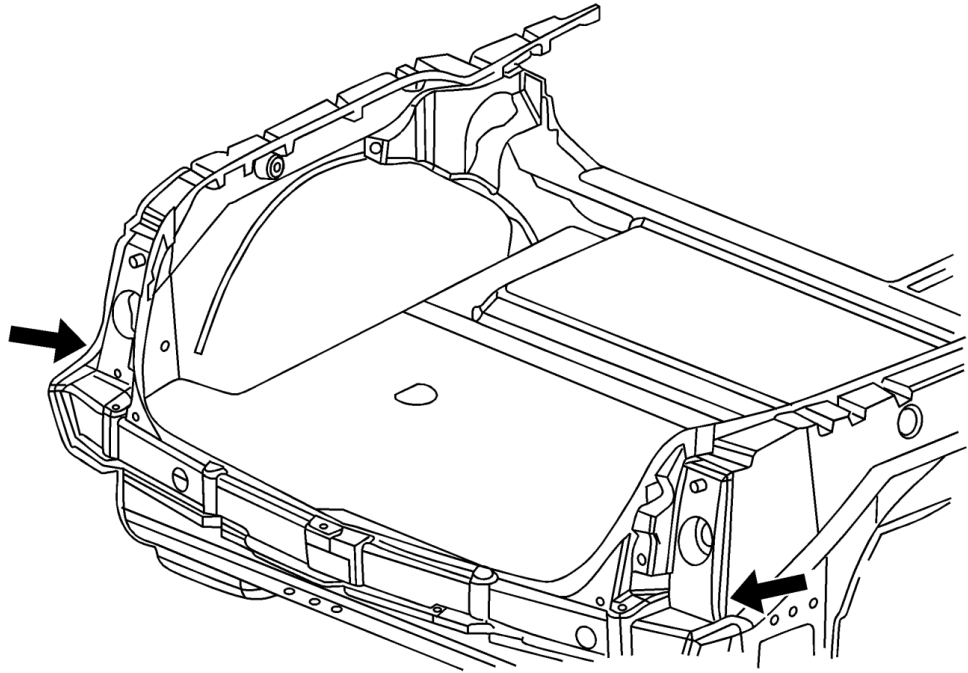
Water entry into rear tubs located behind the rear wheelhouses traced

to the area behind the rear tail lamps.

There are a number of panels that are bonded together in this area. If water entry is traced to this area, remove the rear tail lamp on the affected side to help gain access. Use Kent Seam Sealer, P/N P10200, to seal the affected joint. Refer to the illustration above.
