2004 - 2009 Cadillac XLR: Service Bulletin: #05-08-57-005B: General Waterleak Guide - (Oct 2, 2008)

Subject: General Waterleak
Guide

Models: 2004 - 2009 Cadillac
XLR

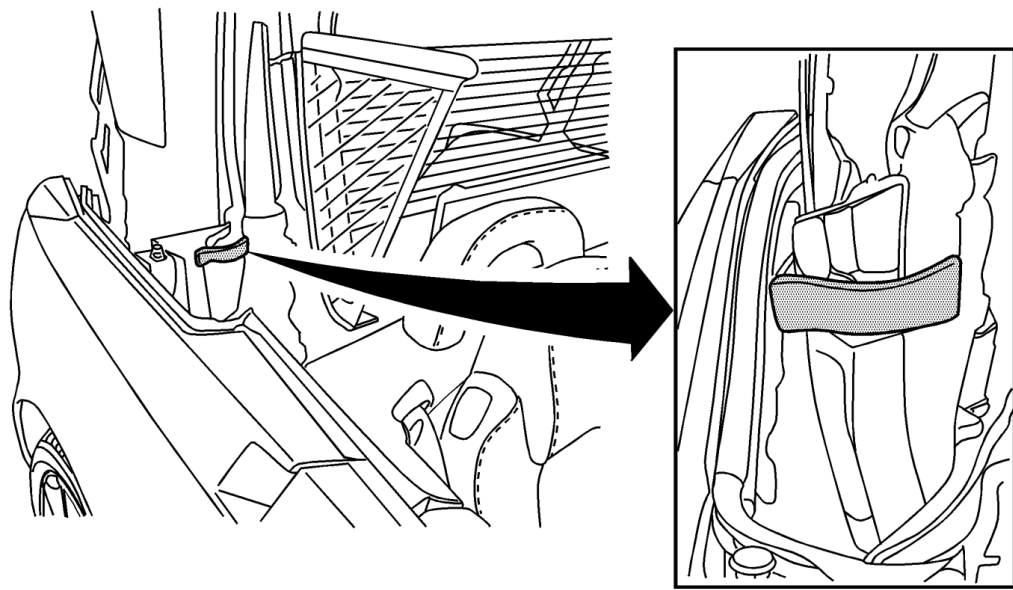
Water entry over wheel house and traced back to quarter belt cup. The cup drain is not large enough to allow water to drain adequately and floods over the dry side of the sealing system, which allows water to enter the trunk.

The cup joint is located at the rear of the quarter belt seal and it looks like a trough. This area is where the rear roof panel lower weatherstrip contacts when the roof is closed. The area just forward (toward front of car) of this cup is a “wet area” and to better manage the water into this wet area, a strip of foam must be added into the rear roof panel lower weatherstrip where it contacts the cup. Cut a strip of adhesive backed foam Kent Adhesive – Back Shim Stock, P/N P46475, 60 mm X 15 mm (2 1/4 in X 5/8 in). Clean the area of the rear roof panel lower weatherstrip where the foam will be added using de-natured alcohol before installing the foam strip to ensure adhesion. Refer to the illustration above.
