2004 - 2009 Cadillac XLR: Service Bulletin: #07-08-57-003A: Waterleak in Trunk When Parked on Hill/Incline

Subject: Waterleak in Trunk
When Parked On
Hill/Incline (Apply
Adhesive Shim Stock)

Models: 2004-2009 Cadillac
XLR

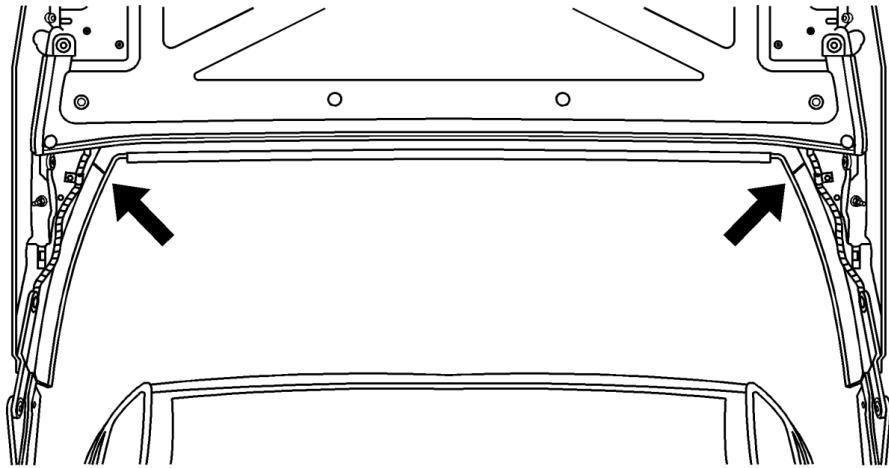
This condition may be caused by a dip in the two bond joints in the trunk inner panel.

1. Clean the shaded area shown in the first illustration above. Apply a small amount of weatherstrip adhesive to the center of the two bond joints. Refer to the second illustration above.
