2004 - 2009 Cadillac XLR: Service Bulletin: #07-08-57-003A: Waterleak in Trunk When Parked on Hill/Incline

#07-08-57-003A: Waterleak in Trunk When Parked on Hill/Incline (Apply Adhesive Shim Stock) - (Oct 14, 2008)

Models: 2004-2009 Cadillac
XLR

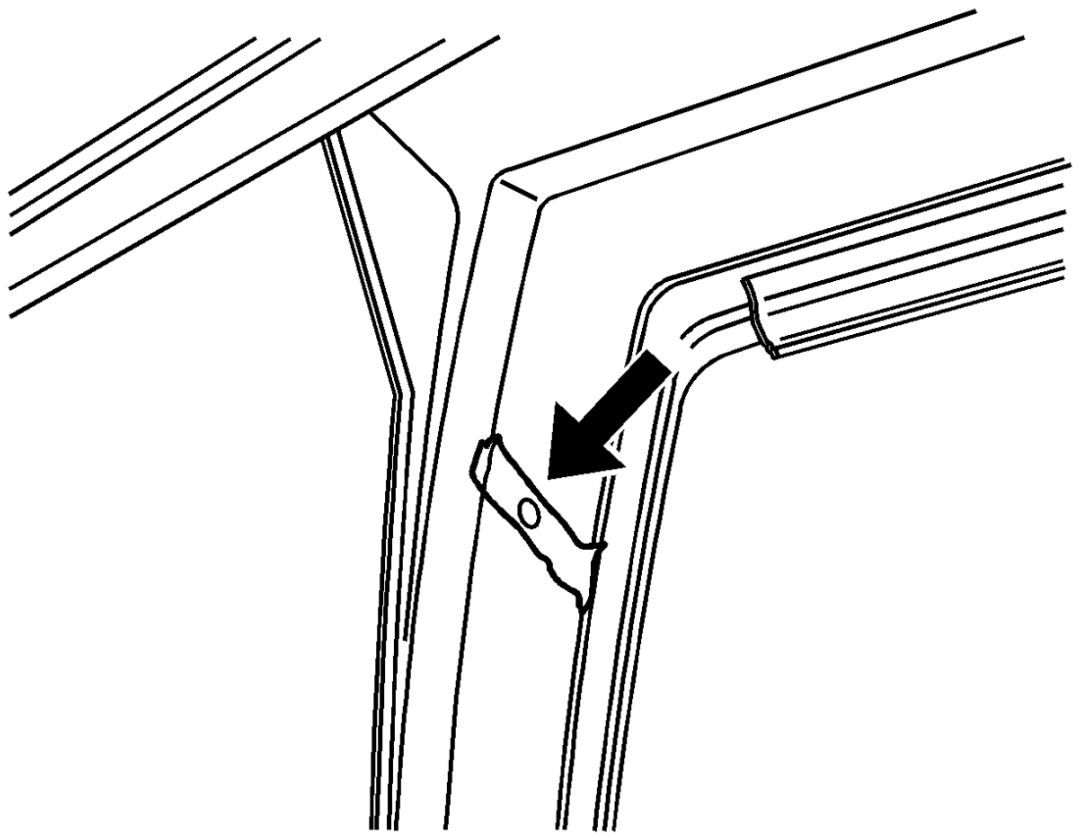
This condition may be caused by a dip in the two bond joints in the trunk inner panel.

1. Clean the shaded area shown in the first illustration above. Apply a small amount of weatherstrip adhesive to the center of the two bond joints. Refer to the second illustration above.
