2004 - 2009 Cadillac XLR: Service Bulletin: #PIC6378: Diagnosing Various Concerns On A Power Folding Top

#PIC6378: Diagnosing Various Concerns On A Power Folding Top - (Dec 17, 2019)

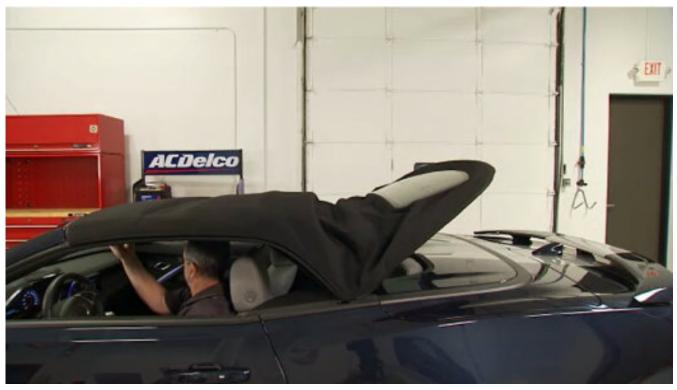
Example Case: Let's take a 2018 Chevrolet Camaro for instance, with a basic folding top concern. The customer states that the top will open fine, but it will not close all the way. A preliminary check will indicate that there is a "Top Not Secure" message in the DIC, but no DTCs are set. The tech is able to duplicate the concern each and every time. When closing, the top will lift up out of the stowage compartment, latch tightly to the windshield header, and the tension bow will lift up to a 45° angle. The Rear Stowage Compartment Lid will lower and lock into position, but the tension bow will not lower. It simply remains suspended in the air as seen in the photo below. The folding top pump quits working and the top stops moving at that point.

On a correctly working car, the stowage compartment lid must close completely before the tension bow is commanded down. Because the steps or phases must be completed in order, the technician must go to the point where the failure occurs, and then go back one step to look at the scan tool data.

Looking at the scan tool sensor data below, we can see that only one of the two Stowage Compartment Lid Closed Position Sensors read "On". Because the Folding Top Control Module will not command the tension bow to lower if both Stowage Compartment Lid Closed Position Sensors are not showing that they are closed, the module thinks that the stowage lid is still raised. As a matter of operation, it will not continue the top cycle. In this instance, the technician must further inspect the Right Folding Top Stowage Compartment Lid Closed Position Sensor to determine what the fault is.
