2009 Cadillac XLR: Service Bulletin: #PIC4930: Audible Click Noise When turning The Steering Wheel Left Or Right

Subject: Audible Click Noise
When Turning the
Steering Wheel Left or
Right

Models: 2009 Cadillac XLR
2009 Chevrolet Corvette

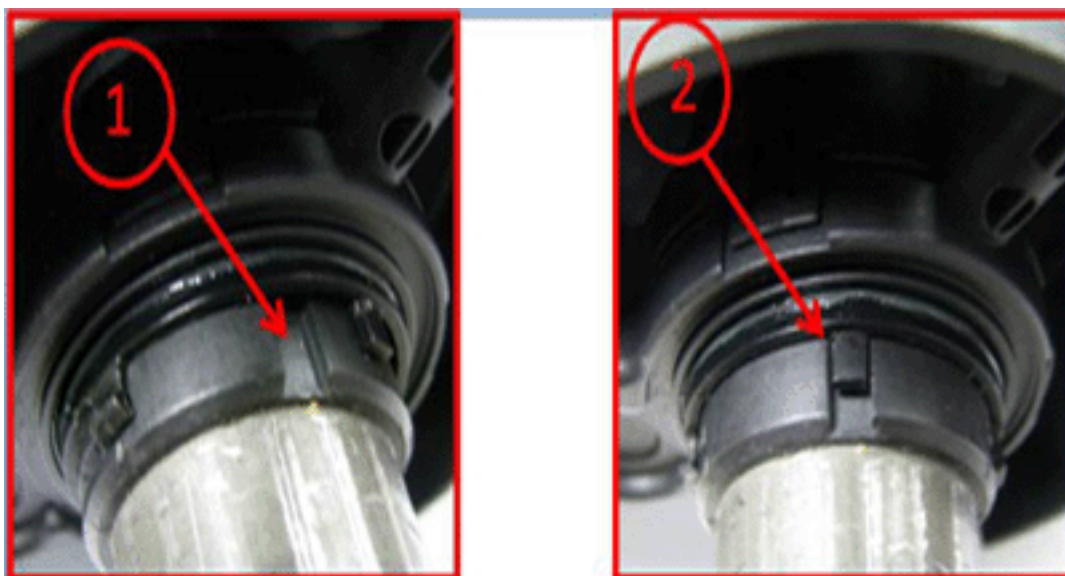
Some customers may comment of a click noise from the steering column when turning the steering wheel left or right. This will typically occur when the vehicle is not moving and the steering wheel is turned either left or right. This may be caused by the Steering Wheel Position Sensor (SWPS) not being installed correctly on the steering column.

2. Refer to the image above. Inspect the vehicle to be sure the Steering Wheel Position Sensor (SWPS) is installed correctly. In call out number 1 above, the SWPS is not installed correctly. Note: the SWPS has a tab that should rest in the opening as called out in number 2 above. In call out number 2 above, the SWPS is installed correctly. Note: The tab of the SWPS is secured in the opening. If the sensor is found to be installed incorrectly, remove or rotate the sensor so that it is installed correctly as shown in call out number 2 above.
