# 2009 Cadillac XLR: Service Bulletin: #PIC4930: Audible Click Noise When turning The Steering Wheel Left Or Right

**Subject:** Audible Click Noise  
When Turning the  
Steering Wheel Left or  
Right

**Models:** 2009 Cadillac XLR  
2009 Chevrolet Corvette

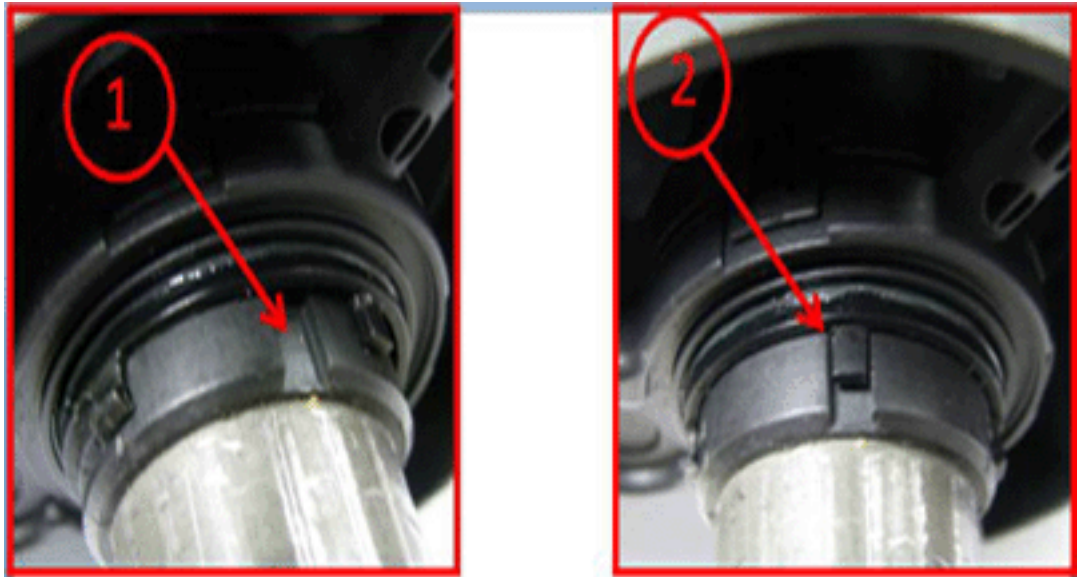
Some customers may comment of a click noise from the steering column when turning the steering wheel left or right. This will typically occur when the vehicle is not moving and the steering wheel is turned either left or right. This may be caused by the Steering Wheel Position Sensor (SWPS) not being installed correctly on the steering column.

2. Refer to the image above. Inspect the vehicle to be sure the Steering Wheel Position Sensor (SWPS) is installed correctly. In call out number 1 above, the SWPS is not installed correctly. Note: the SWPS has a tab that should rest in the opening as called out in number 2 above. In call out number 2 above, the SWPS is installed correctly. Note: The tab of the SWPS is secured in the opening. If the sensor is found to be installed incorrectly, remove or rotate the sensor so that it is installed correctly as shown in call out number 2 above.

1. Remove the close out panel just below the steering column.
