# **2006 - 2009 Cadillac XLR: Service Bulletin: #PI0299: Harsh Shifts After Replacement of 1-2-3-4 / 3-5-R Clutch Housing**

## **#PI0299: Harsh Shifts After Replacement of 1-2-3-4 / 3-5-R Clutch Housing - (Nov 16, 2010)**

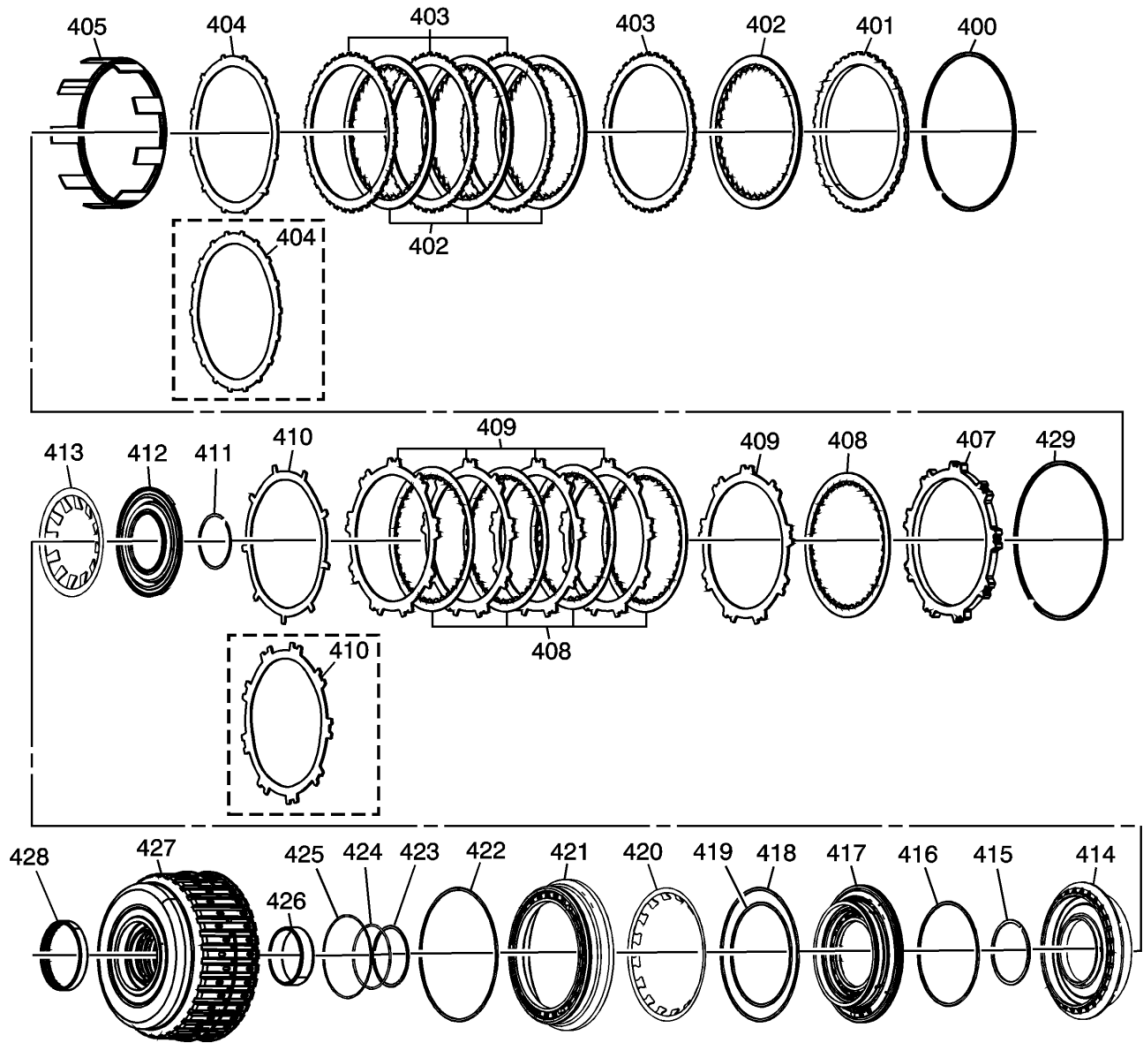
Some customers may comment on harsh shifts after replacement of the 1-2-3-4 / 3-5-R clutch housing (427).

This condition may be caused if the 1-2-3-4 / 3-5-R bearing (428) is not installed into the housing (427). The 1-2-3-4 / 3-5-R clutch housing is currently serviced through parts without this bearing installed and failure to order and install this bearing may result in harsh shifts. Plans are being implemented to service this housing as a kit that will include the bearing.

**Note:** The parts catalog calls out to order the bearing when the housing is also replaced.
