2004 - 2009 Cadillac XLR Service Bulletin: #PIC5000: Quarter Glass Lands On Top Of Quarter Belt Seal

#PIC5000: Quarter Glass Lands On Top Of Quarter Belt Seal - (Oct 13, 2008)

Models: 2004 - 2009 Cadillac
XLR model vehicles.

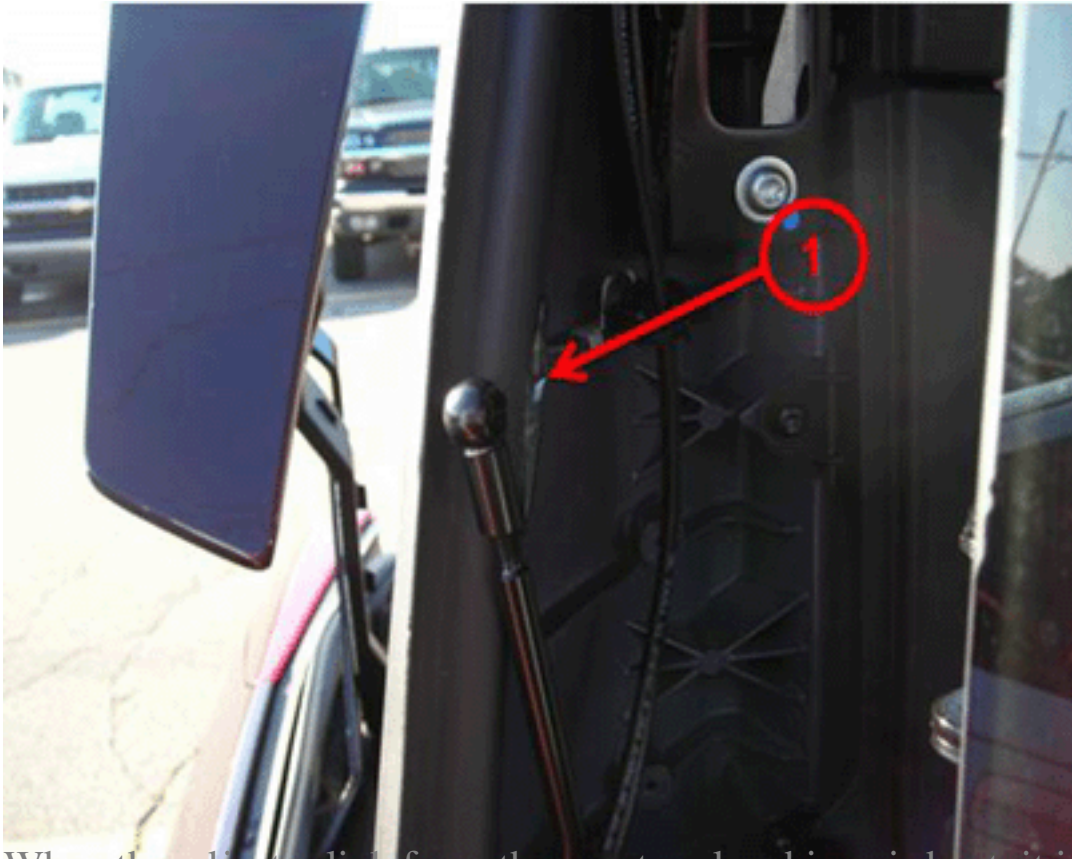
When the adjuster link from the quarter glass hinge is bent, it is outboard. Refer to call out 1 in the illustration above. Bend the link back inboard until it will just touch the inside surface of the weatherstrip. When in the right position it could be forced passed the weather strip with minimal effort.

- If you have attempted to adjust the quarter glass using the adjuster, put it back to the original position.
- With the weather strip installed in the retainer cycle the roof down to ensure that the quarter glass is landing in the channel of the weather strip.
- It should contact at the rear inboard lip of the quarter belt seal first. Watch the opposite side for a reference.
- If not quite right you can slightly bend the adjuster rod again to correct.
- Once the quarter glass is landing properly apply adhesive to the to the quarter belt seal per the next step. Perform this on both sides of the vehicle.

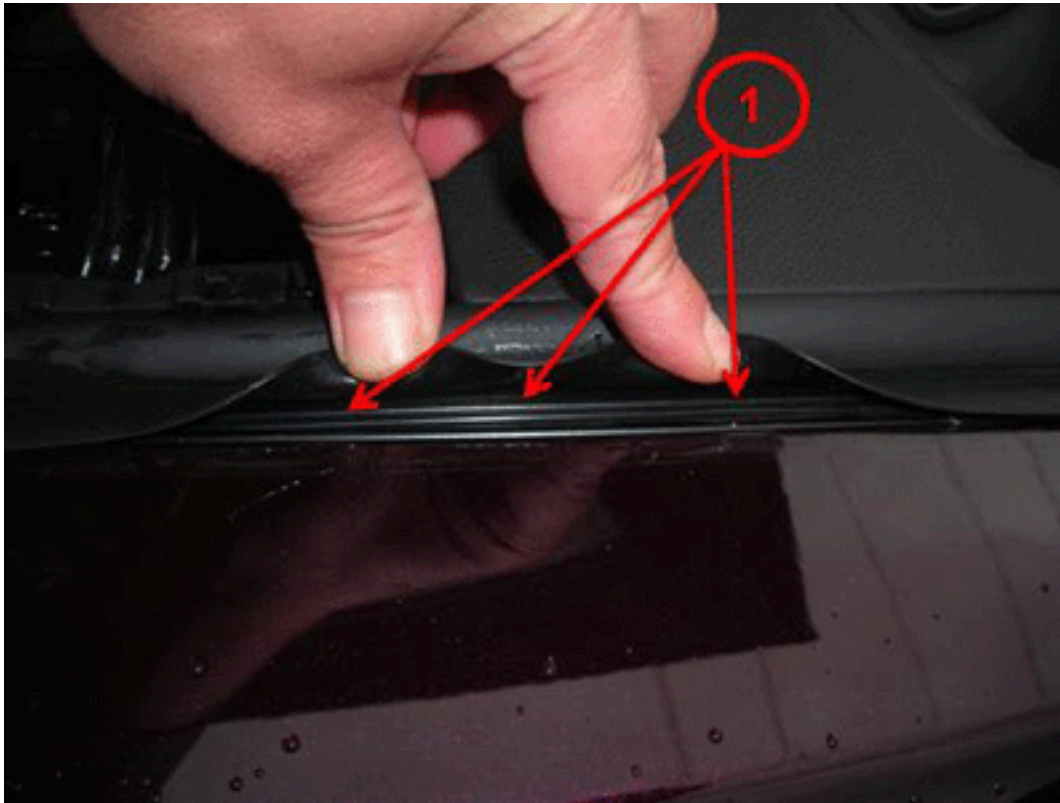
Some customers may comment that the quarter glass lands on top of the quarter belt seal when closing the retractable roof. The cause of the issue is typically that the quarter glass (QG) has pulled the quarter belt seal (QBS) out of the retainer during the previous cycle. It then lands on the seal when closing the roof which bends the quarter glass adjuster link. If bent far enough, it can cause the quarter glass to be outboard enough that the door glass will come up on the inside of the quarter glass and prevent the door from opening when the door glass is up. When the QG lands on top of the QBS it bends the QG adjuster link outboard. The following procedure shows how to correct the bent link and retain the QBS so the condition will not reoccur.

Push the quarter belt seal out of the outboard side of the retainer. Apply weatherstrip adhesive on the weatherstrip where it engages the retainer lip, see call out 1 in the illustration above. Reinstall the weatherstrip into the retainer. Lower the roof to hold the weatherstrip in place until the adhesive cures.
