# **2006 - 2009 Cadillac XLR XLR-V: Service Bulletin: Slips in Reverse or Third, Delayed Reverse or Drive Engagement**

## **#09-07-30-004J: Slips in Reverse or Third, Delayed Reverse or Drive Engagement, DTC P0776, P2715, P2723, Harsh 2-3 Shifts (Inspect 1-2-3-4 / 3-5-R Housing and Pump Seal Rings) - (Feb 25, 2014)**

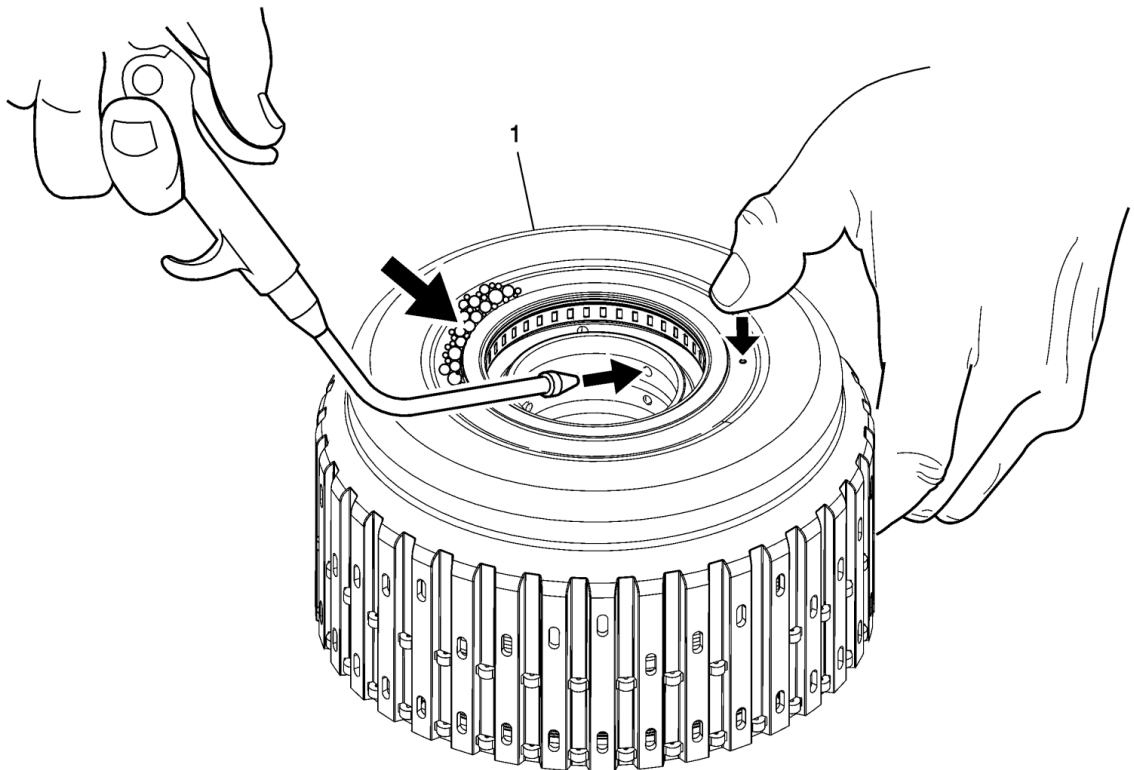
## **Housing Assembled**

This condition may be caused by a cracked 1-2-3-4 / 3-5-R clutch housing.

Inspect the 1-2-3-4 / 3-5-R clutch housing for a possible cracked weld. The housing can be inspected either assembled or disassembled.

**Important:** If a cracked housing is identified, it must be replaced. Complete, assembled 1-2-3-4 / 3-5-R clutch housings are now available for most applications. These clutch housings come complete with all pistons, seals, clutches, bearing and internal parts. No assembly of the clutch housing is required before it is installed. For applications without a complete, assembled 1-2-3-4 / 3-5-R clutch housing, individual parts must be ordered and the housing assembled in the

1. Apply soap compound to the weld area of the housing.
2. Hold your thumb over the air bleed passage.
3. For a fully assembled 1-2-3-4 and 3-5 reverse clutch housing, spray compressed air into the 3-5R clutch feed hole and inspect the weld area for bubbles.
4. If bubbles are detected, a new housing is required.

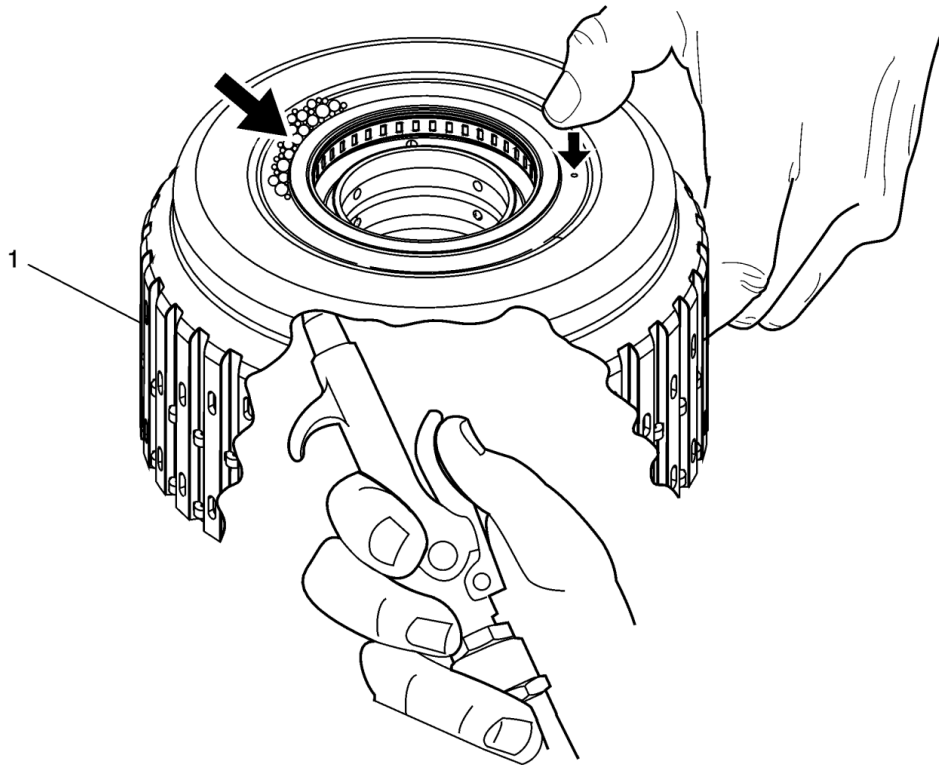
## **Housing Disassembled**

Inspect the 1-2-3-4 / 3-5-R clutch housing for a possible cracked weld.

1. Apply soap compound to weld area of the housing.
2. Hold your thumb over the air bleed passage.
3. Spray compressed air into the housing and inspect the weld area for bubbles.
4. If bubbles are detected, a new housing is required.

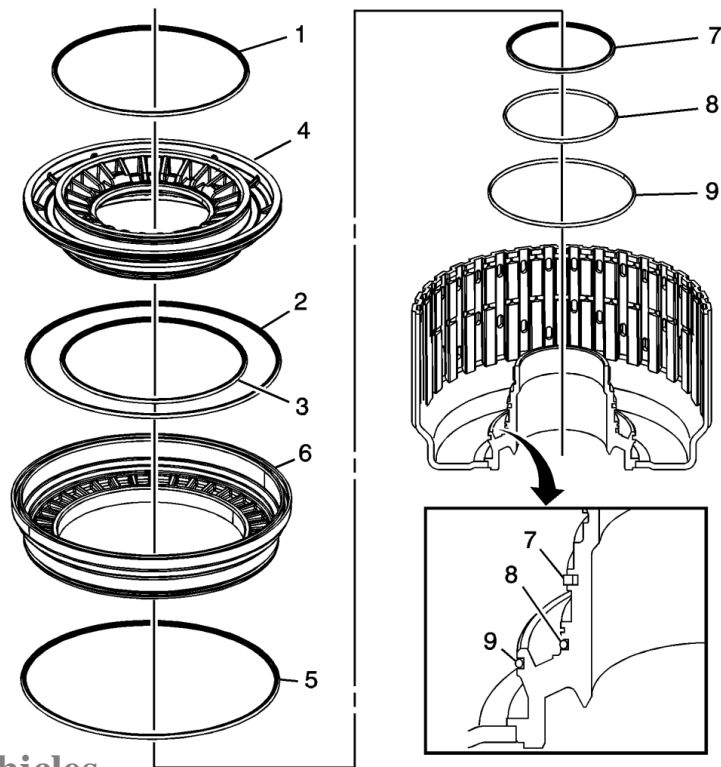
**Important:** The 6L80 transmission had a design change to the 1-2-3-4 piston, 1-2-3-4 piston housing and the 3-5-R piston for the 2008 model year. Installation of a 2008, 6L80 complete housing assembly into a 2007 or older 6L80 may result in a 2-3 shift flare or 3-5-R clutch distress.

**Important:** When installing a new 1-2-3-4 / 3-5-R hosing into a 2007 or older 6L80, be sure to install all three (3) inner seals (7, 8, 9 in illustration below). Failure to install these seals can result in no reverse, no forward or distressed clutches.

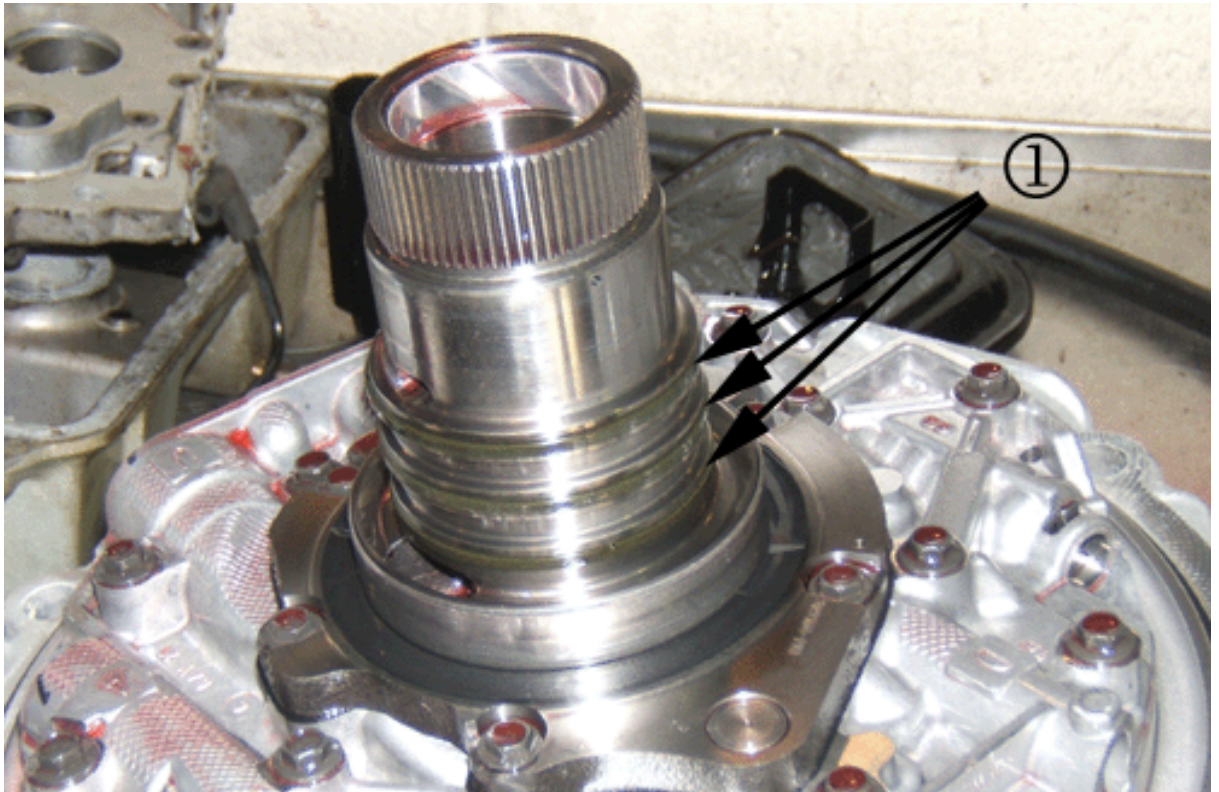
A harsh 2-3 shift condition may be caused by leaking 1-2-3-4 and 3-5-R clutch fluid seal rings (1) on the transmission fluid pump cover assembly.

Inspect the fluid seal rings. Transmissions in 2006, 2007, 2008 and early build 2009 models used a 1- piece design seal ring in production. Starting December 2008, a 2-piece seal ring design was implemented. The 1-piece seal ring design may cause a harsh 2-3 shift due to leakage. This is typically a low mileage issue. If the seal rings are a 1-piece design they should be replaced with new 1-piece design seal rings. It is not necessary to replace the pump cover.

**Notice:** The clutch fluid seal rings must be installed in a specific way. Failure to install new clutch fluid seal rings in the proper orientation may cause a repeat harsh 2-3 shift. Refer to 1-2-3-4 and 3-5 Reverse Clutch Fluid Seal Ring Installation (6L80/90) in SI for correct installation.

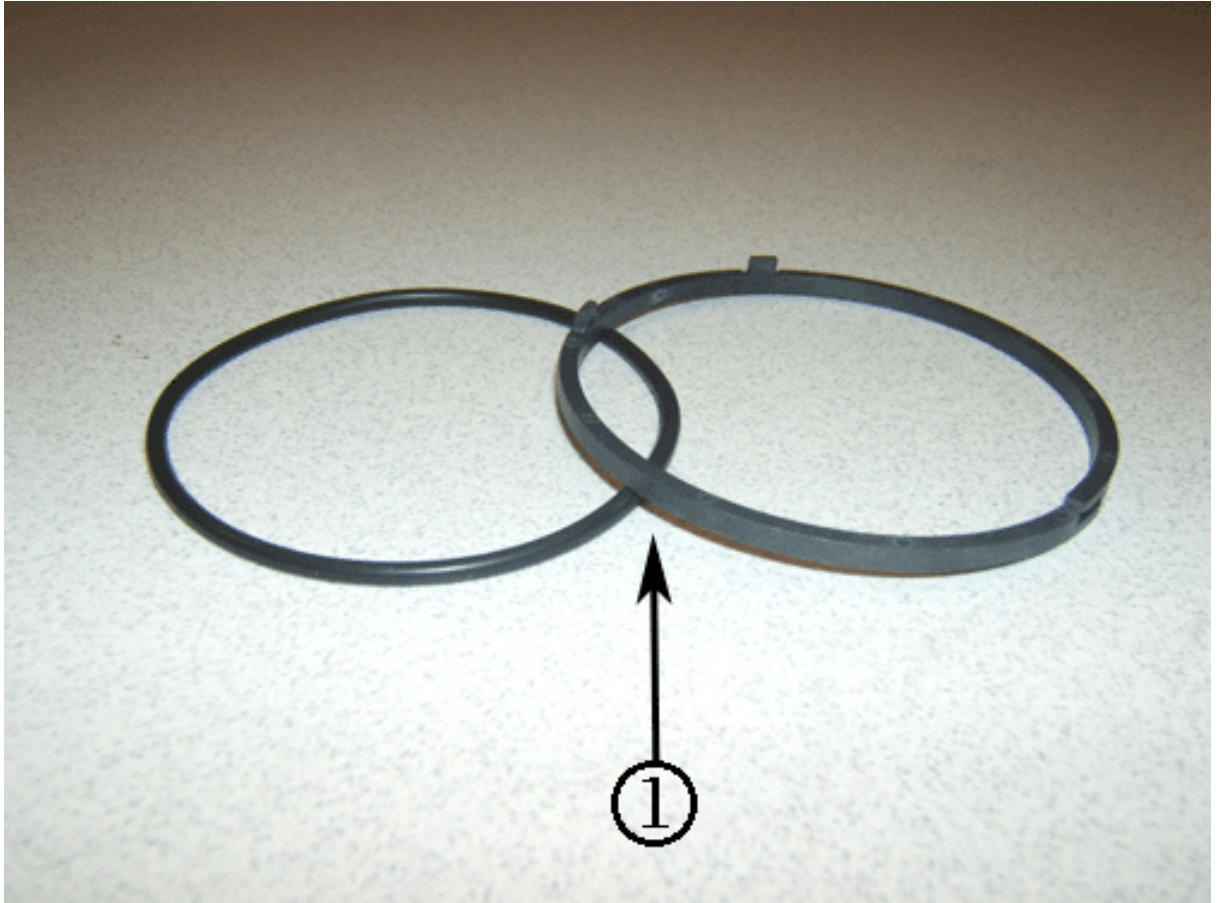
If the seals are the 2-piece design shown below, they do not need to be replaced unless they are worn or damaged.

**Important:** Do not install 1-piece design seal rings on a 2-piece seal

ring design pump cover. The 2-piece seal ring design pump cover can be identified by the notch in the seal ring grooves that accepts the tab on the 2-piece design seal rings.
