2006 - 2009 Cadillac XLR XLR-V: Service Bulletin: Slips in Reverse or Third, Delayed Reverse or Drive Engagement

#09-07-30-004J: Slips in Reverse or Third, Delayed Reverse or Drive Engagement, DTC P0776, P2715, P2723, Harsh 2-3 Shifts (Inspect 1-2-3-4 / 3-5-R Housing and Pump Seal Rings) - (Feb 25, 2014)

Models: 2006 - 2009 Cadillac STS-V, XLR, XLR-V
2007 - 2008 Cadillac Escalade, Escalade ESV, Escalade EXT
2006 - 2009 Chevrolet Corvette
2007 - 2008 Chevrolet Silverado
2008 Chevrolet Suburban
2007 - 2008 GMC Sierra, Sierra Denali, Yukon Denali, Yukon XL Denali
2008 GMC Yukon XL
2008 - 2009 HUMMER H2
2008 - 2009 Pontiac G8
Equipped with 6L80 or 6L90 Automatic Transmission (RPOs MYC, MYD)

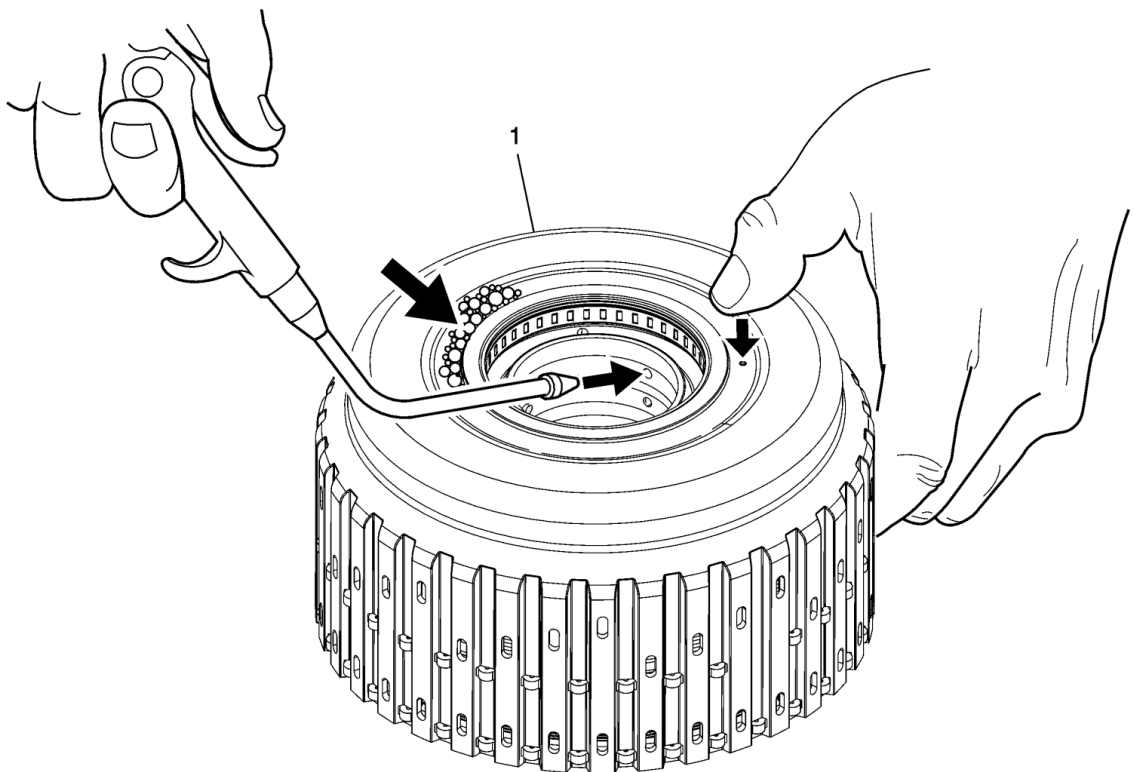
Housing Assembled

This condition may be caused by a cracked 1-2-3-4 / 3-5-R clutch housing.

Inspect the 1-2-3-4 / 3-5-R clutch housing for a possible cracked weld. The housing can be inspected either assembled or disassembled.

1. Apply soap compound to the weld area of the housing.
2. Hold your thumb over the air bleed passage.
3. For a fully assembled 1-2-3-4 and 3-5 reverse clutch housing, spray compressed air into the 3-5R clutch feed hole and inspect the weld area for bubbles.
4. If bubbles are detected, a new housing is required.

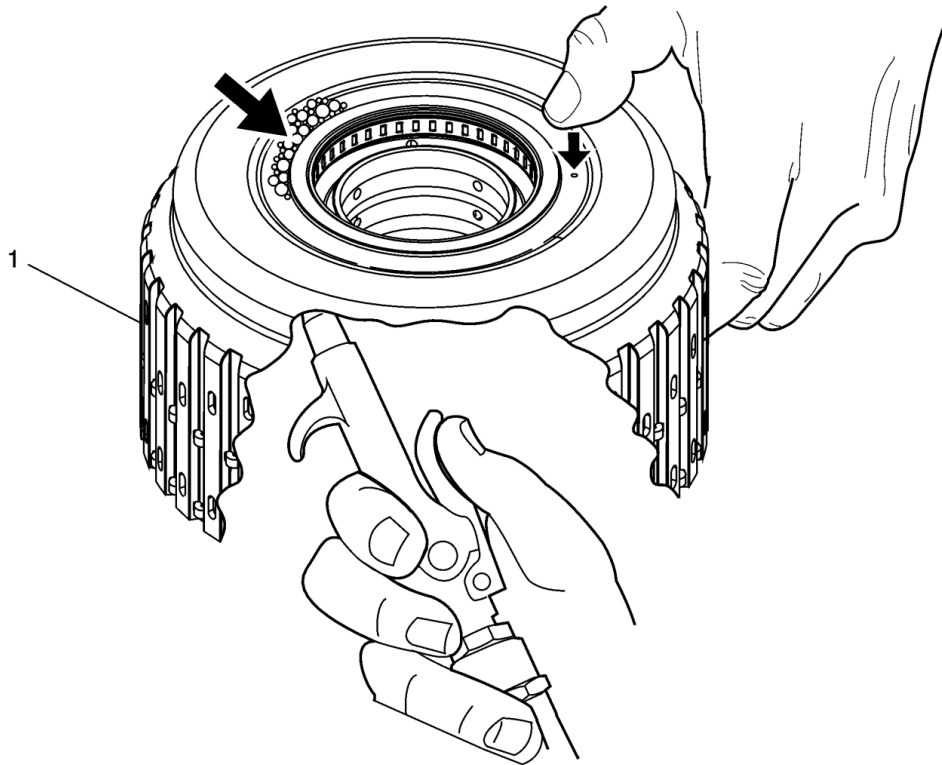
Housing Disassembled

Inspect the 1-2-3-4 / 3-5-R clutch housing for a possible cracked weld.

1. Apply soap compound to weld area of the housing.
2. Hold your thumb over the air bleed passage.
3. Spray compressed air into the housing and inspect the weld area for bubbles.
4. If bubbles are detected, a new housing is required.

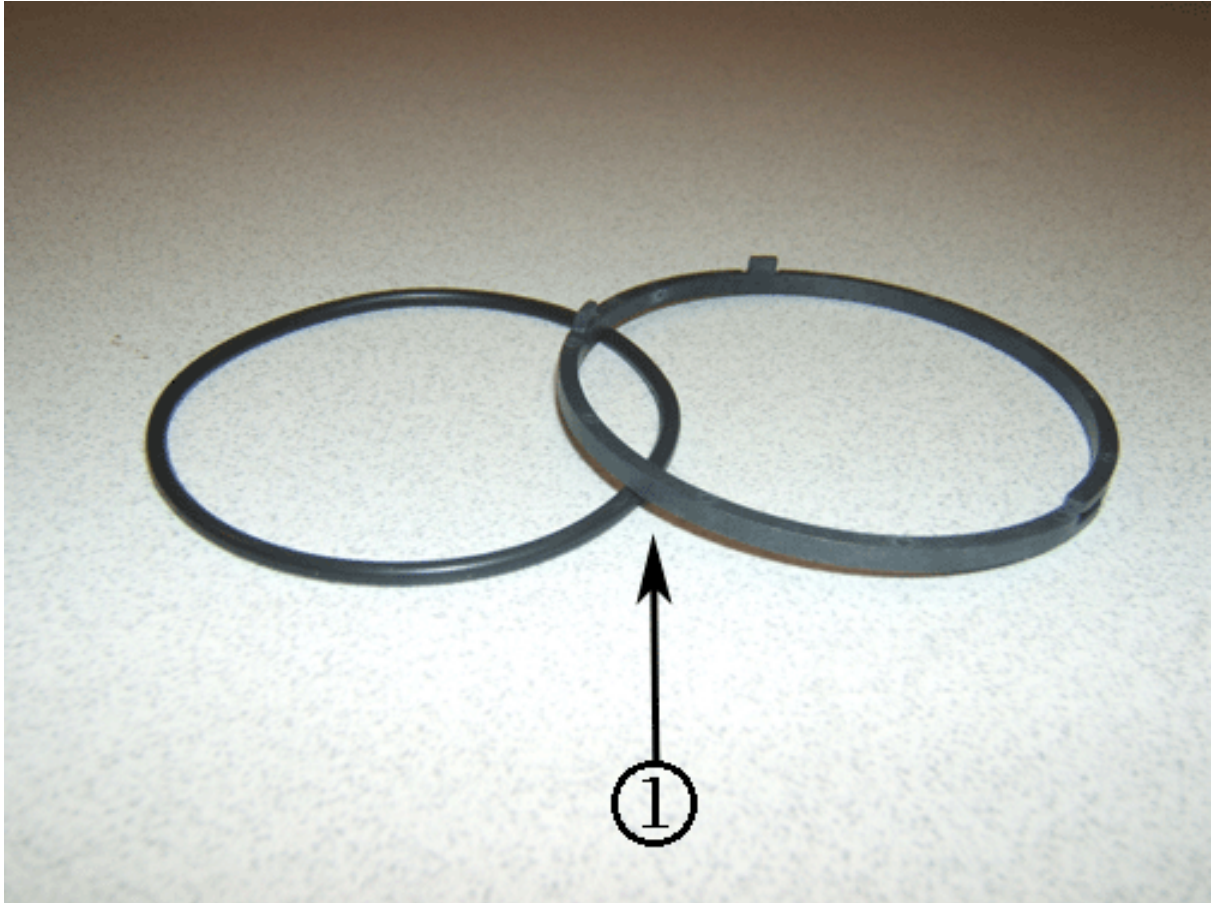
If the seals are the 2-piece design shown below, they do not need to be replaced unless they are worn or damaged.

ring design pump cover. The 2-piece seal ring design pump cover can be identified by the notch in the seal ring grooves that accepts the tab on the 2-piece design seal rings.

Important: Do not install 1-piece design seal rings on a 2-piece seal
