2006 - 2009 Cadillac XLR XLR-V: Service Bulletin: Slips in Reverse or Third, Delayed Reverse or Drive Engagement

#09-07-30-004J: Slips in Reverse or Third, Delayed Reverse or Drive Engagement, DTC P0776, P2715, P2723, Harsh 2-3 Shifts (Inspect 1-2-3-4 / 3-5-R Housing and Pump Seal Rings) - (Feb 25, 2014)

Models: 2006 - 2009 Cadillac STS-V, XLR, XLR-V
2007 - 2008 Cadillac Escalade, Escalade ESV, Escalade EXT
2006 - 2009 Chevrolet Corvette
2007 - 2008 Chevrolet Silverado
2008 Chevrolet Suburban
2007 - 2008 GMC Sierra, Sierra Denali, Yukon Denali, Yukon XL Denali
2008 GMC Yukon XL
2008 - 2009 HUMMER H2
2008 - 2009 Pontiac G8
Equipped with 6L80 or 6L90 Automatic Transmission (RPOs MYC, MYD)

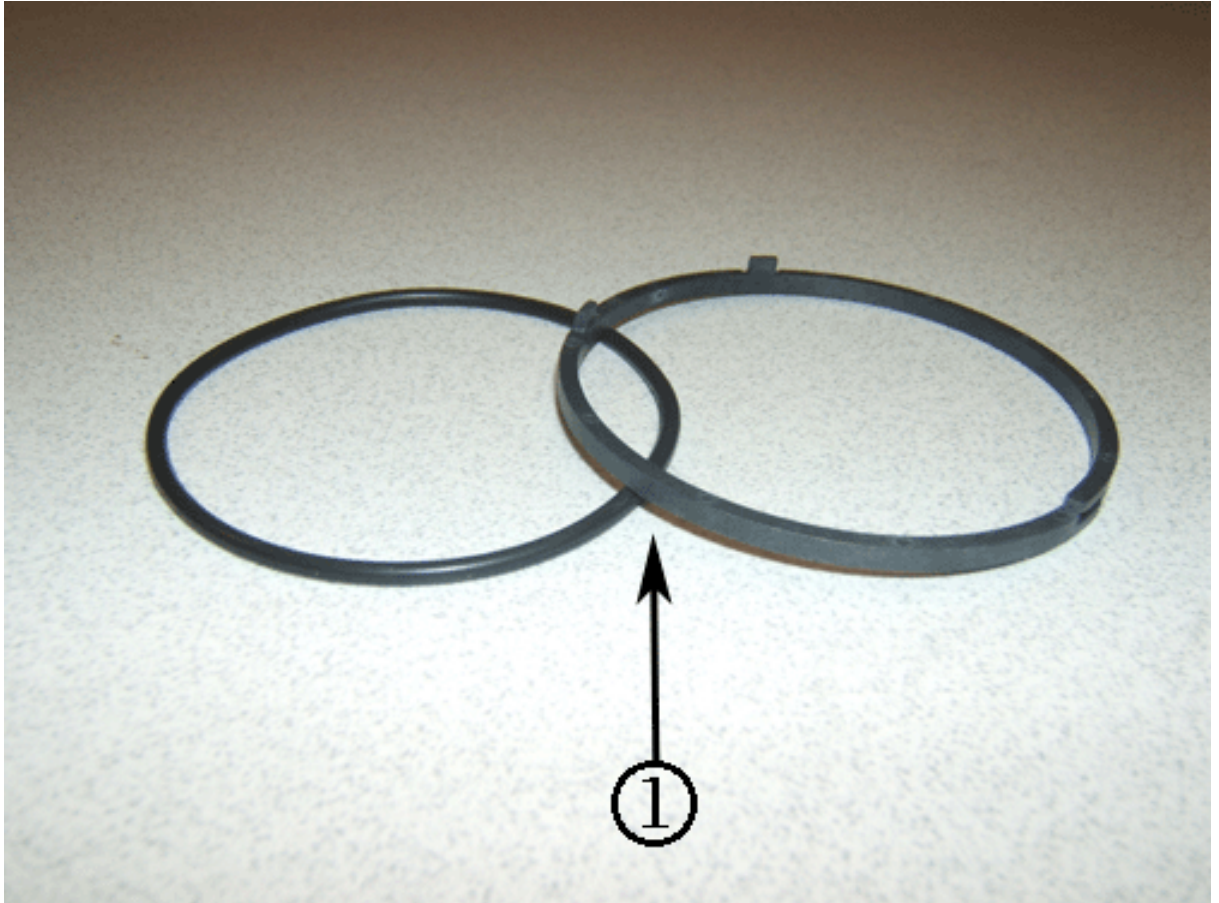
If the seals are the 2-piece design shown below, they do not need to be replaced unless they are worn or damaged.

Important: Do not install 1-piece design seal rings on a 2-piece seal

ring design pump cover. The 2-piece seal ring design pump cover can be identified by the notch in the seal ring grooves that accepts the tab on the 2-piece design seal rings.
