# 2006 - 2008 Cadillac XLR-V: Service Information: 6L80 or 6L90 Automatic Transmission Shift Conditions

**Source:** GM Techlink

**Date:** October 2011

**Subject:** 6L80 or 6L90 Automatic Transmission Shift Conditions

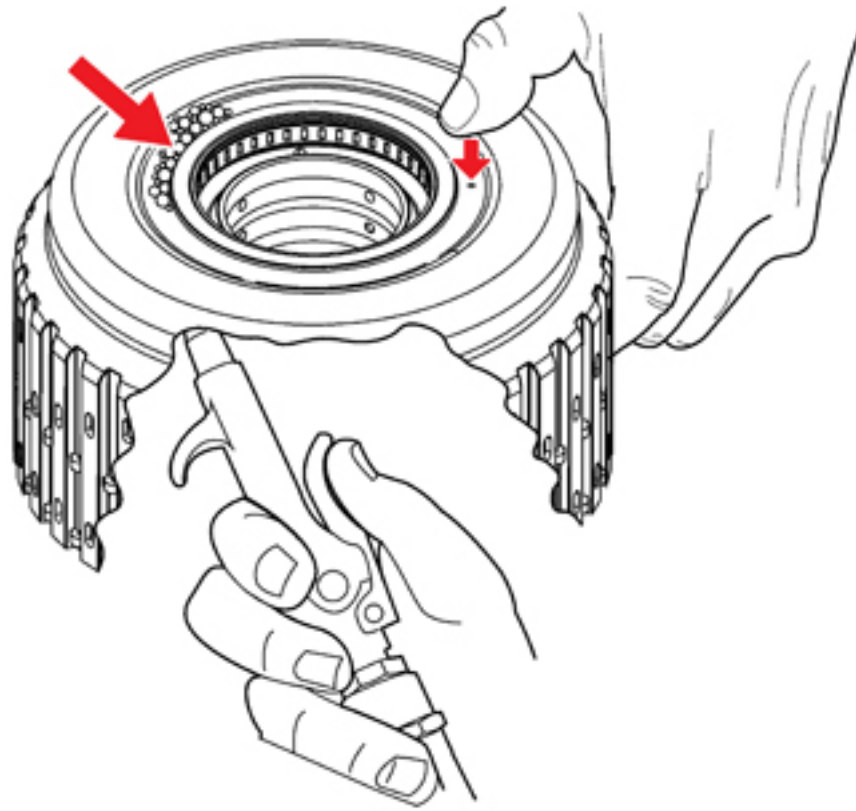
**Fig. 14**

A cracked 1-2-3-4/3-5-R clutch housing may cause any of the following conditions:

- Slip when Reverse is selected or no Reverse
- Delayed engagement into Reverse
- DTC P0776 set as an active or a history code in the Transmission Control Module, Malfunction Indicator Lamp (MIL) illuminated
- Harsh shifts from Second to Third

Inspect the 1-2-3-4 / 3-5-R clutch housing for a possible cracked weld by applying soap compound to the weld area of the housing. Hold your thumb over the air bleed passage and spray compressed air into the piston housing. Inspect the weld area for bubbles. If bubbles are detected, a new housing is

required. (Fig. 14)
