2004 - 2009 Cadillac XLR: Service Bulletin: Red LED and B2455 After Performing Canada Upgrade Bulletin 15-08-44-001

#PIC6140B: Red LED and B2455 After Performing Canada Upgrade Bulletin 15-08-44-001 - (Dec 21, 2015)

Subject: Red LED and B2455 After Performing Canada Upgrade Bulletin 15-08-44-001

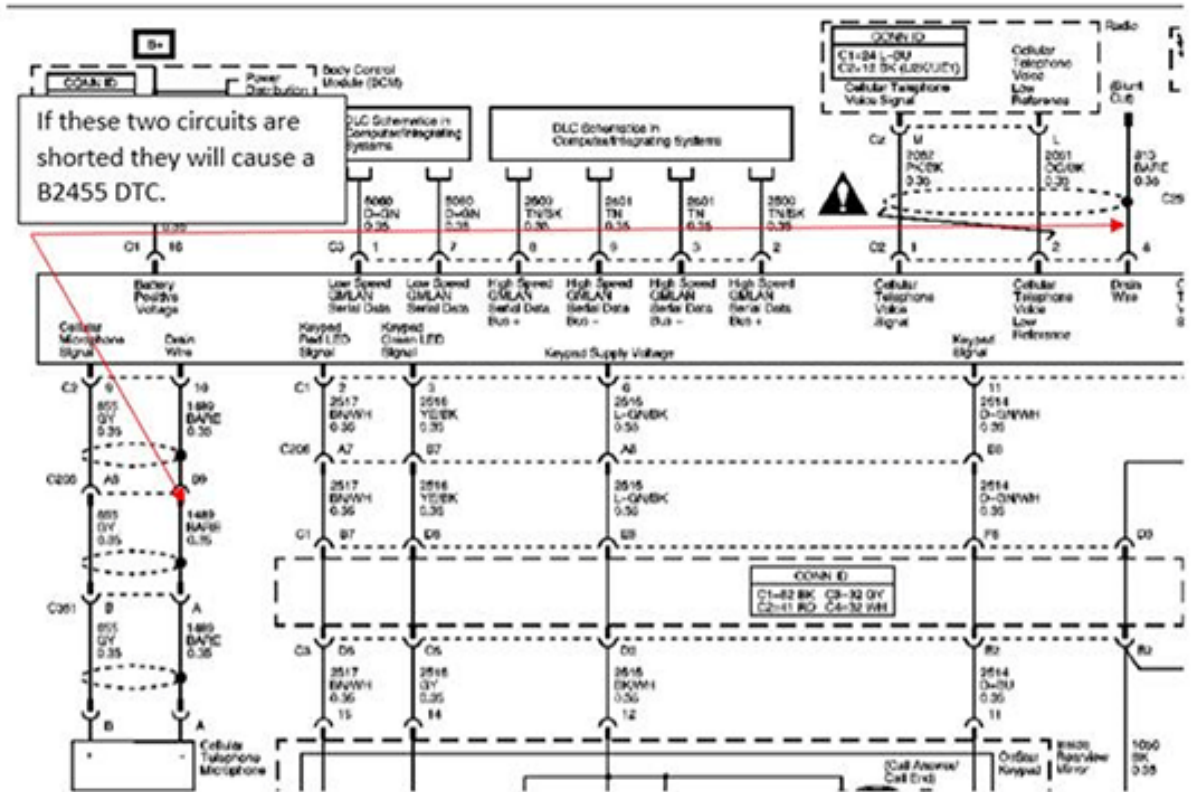
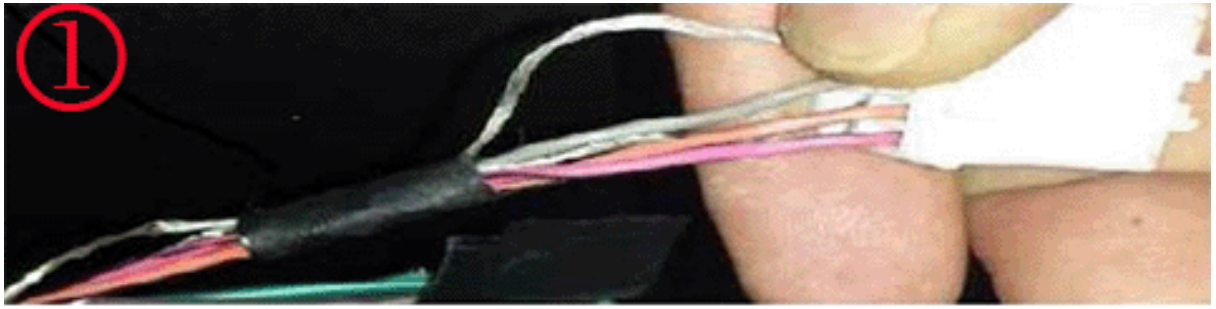
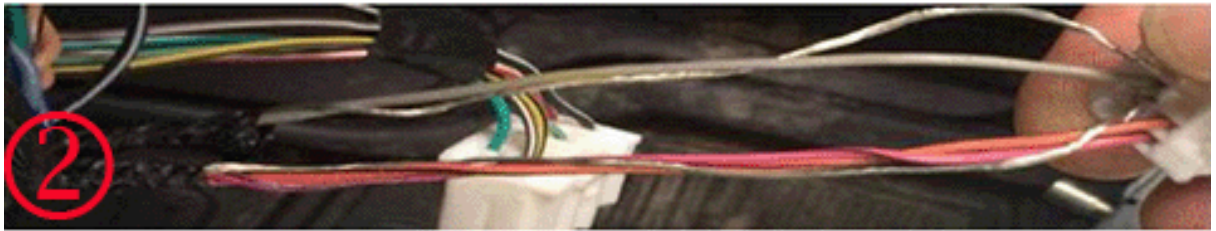
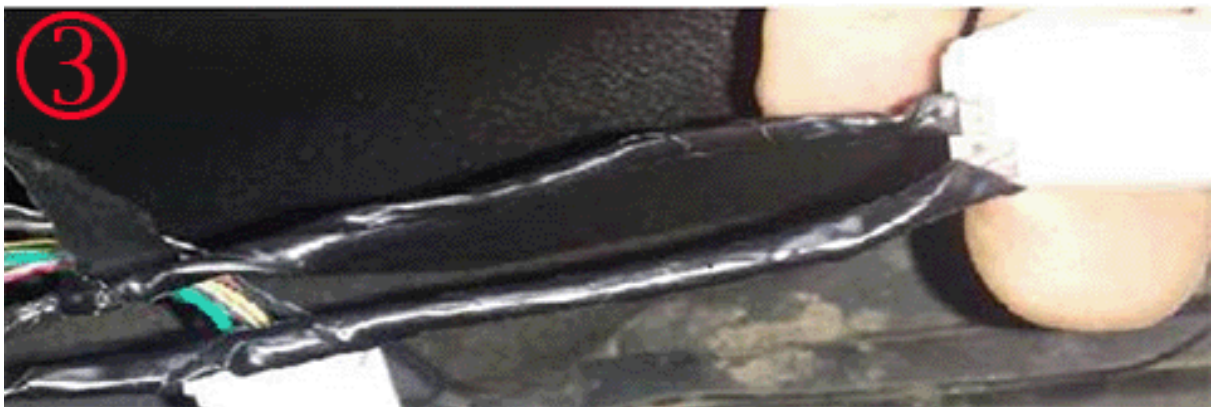
A dealer or customer may notice a red LED and DTC B2455 setting current in the VCIM after performing Canada upgrade bulletin 15-08-44-001.

1. It has been found that a short between the audio drain wire and microphone drain wire will cause this concern.
2. Pull back the tape at X2 of the VCIM far enough to see where the bare wires are covered.
3. Tape the bare wires individually to prevent them from shorting. Then tape the harness back up.
