2004 - 2009 Cadillac XLR: Service Bulletin: #01-07-30-032E: Transmission Oil Leaking From Transmission Vent

#01-07-30-032E: Transmission Oil Leaking From Transmission Vent (Replace Transmission Case Cover (Channel Plate) Gasket) - (Sep 29, 2008)

Models: 1997-2009 GM Passenger Cars
and Light Duty Trucks
(including Saturn)

with Hydra-Matic 4T65-E
Automatic Transmission
(RPOs MN3, MN7, M15,
M76)

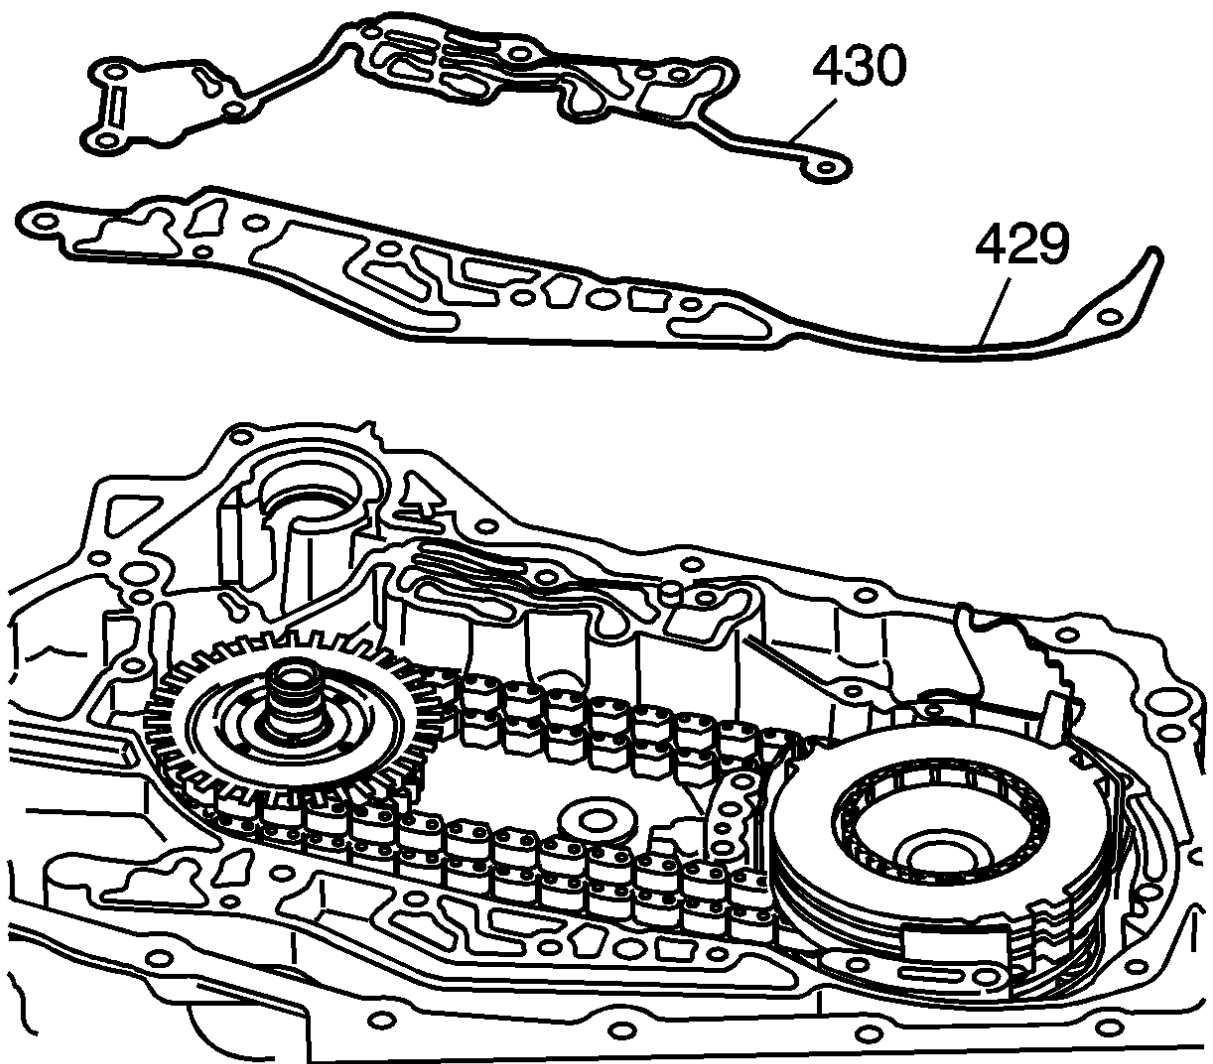
This condition may be caused by an improperly torqued channel plate gasket.

To correct this condition, replace the case cover (channel plate) gaskets (429 and 430). Refer to Unit Repair publication in SI of the appropriate vehicle being serviced.

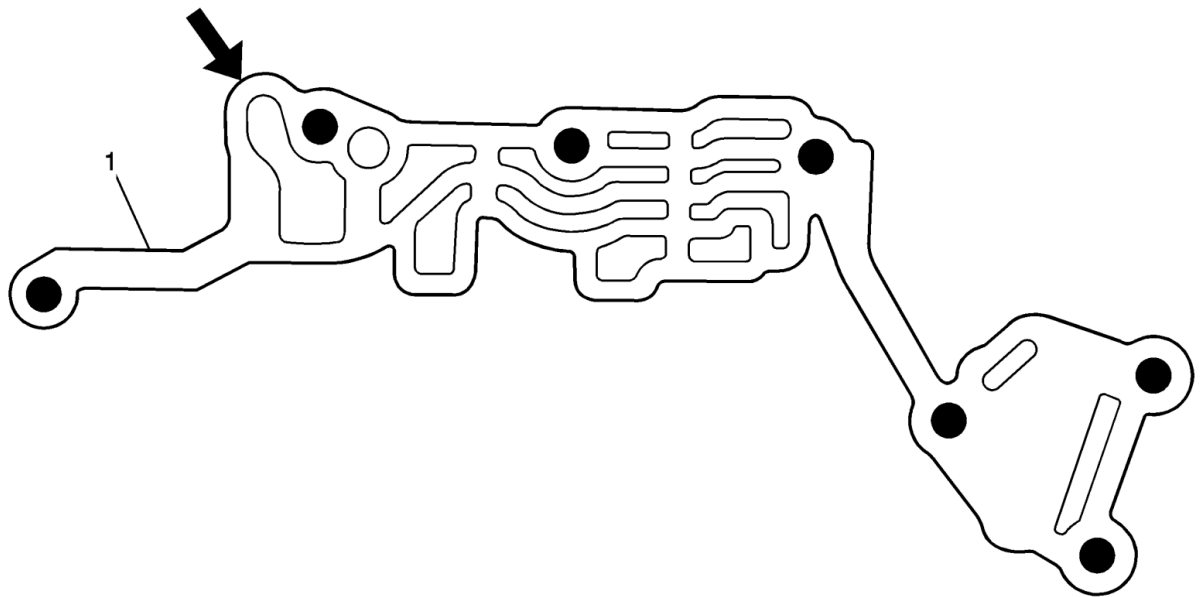
Visual inspection of the upper gasket (1) will reveal damage at the referenced area.
