## 2004 Cadillac XLR: Service Information: HVAC Module Service

This information applies to the 2004 Cadillac XLR and the 2005 Chevrolet Corvette and newer.

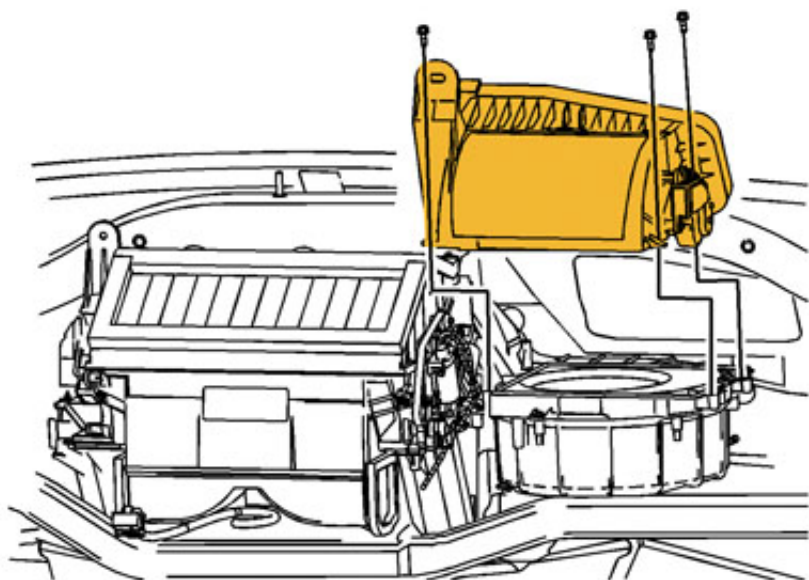
Use special care when removing or installing the HVAC module for service. The HVAC module is seated between a non-removable upper and lower tie bar

Refer to SI 2000 to obtain the service procedure for correctly removing and installing the HVAC module. Failure to do so could result in damage to the HVAC module.

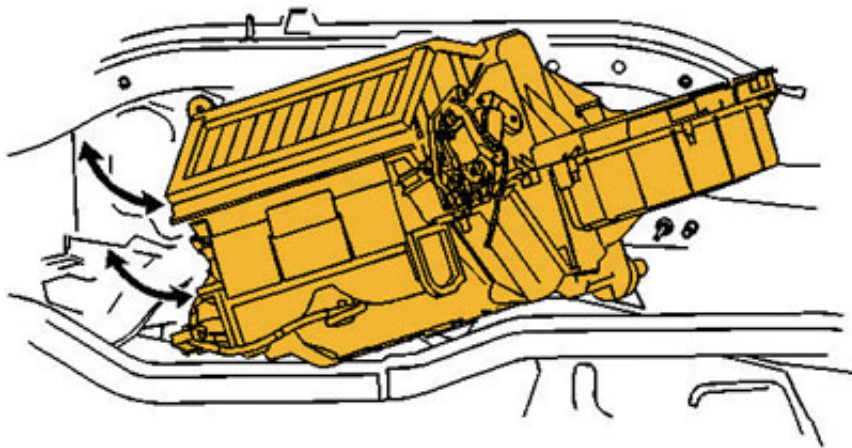
(fig. 11 - attached). The HVAC module must be partially disassembled before removal and installation (fig. 12 - attached).
