## 2004 - 2009 Cadillac XLR: GM TechLink: No Fob Detected Message

**Source:** GM TechLink **Date:** February 20, 2014

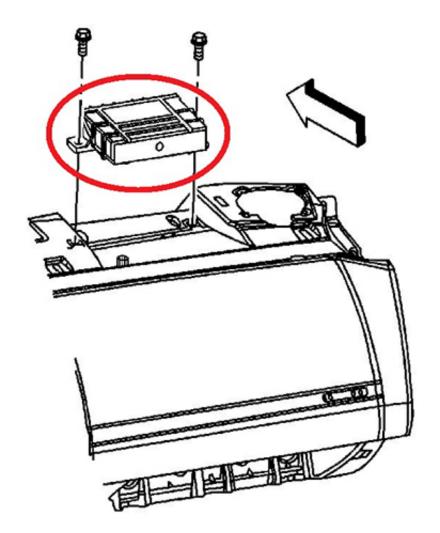
Fig. 13

The RCDLR module on the Corvette is located above the radio behind the instrument panel trim on the right side. (Fig. 12) On the XLR, the RCDLR module is located on the top right of the instrument panel under the upper instrument panel pad. (Fig. 13)

If the vehicle has a known good key fob (not placed in the instrument panel compartment pocket), press the Engine Start Button and listen for a click noise or a series of click noises from the RCDLR. If there is only one click (instead of a series of clicks), the transistor internal to the RCDLR is not operating properly. For this condition, replace the RCDLR module.
