# 2004 Cadillac XLR: Service Information: HVAC Module Service

This information applies to the 2004 Cadillac XLR and the 2005 Chevrolet Corvette and newer.

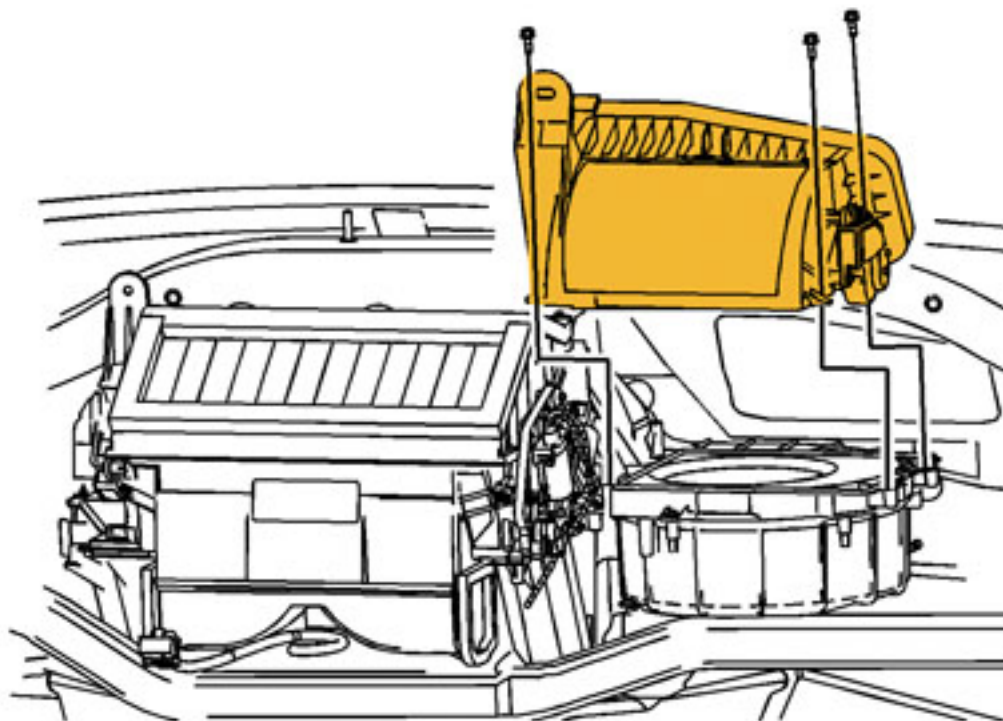
Use special care when removing or installing the HVAC module for service. The HVAC module is seated between a non-removable upper and lower tie bar

([fig. 11 - attached](#)). The HVAC module must be partially disassembled before removal and installation ([fig. 12 - attached](#)).

Refer to SI 2000 to obtain the service procedure for correctly removing and installing the HVAC module. Failure to do could result in damage to the HVAC module.
